CONDITION ASSESSMENT REPORT WITH PICTURES

40 East Main

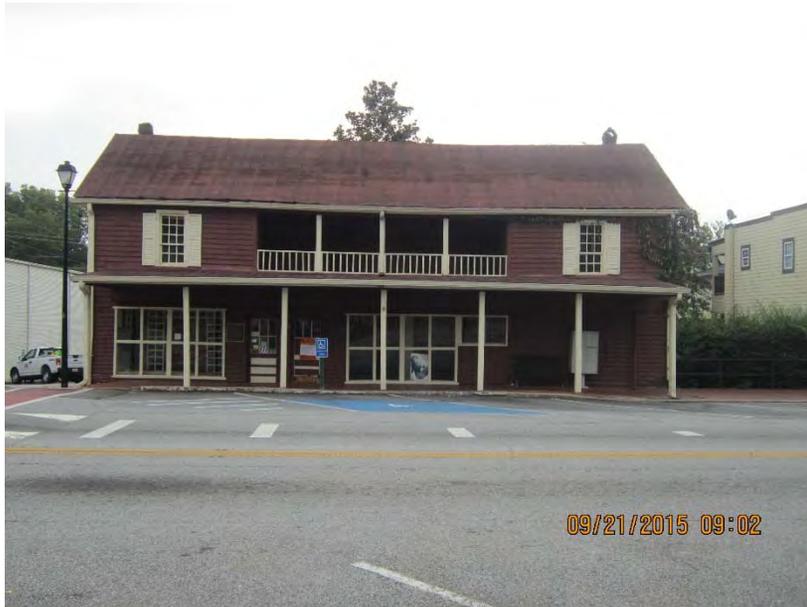
Section 1 Roof

Overall roof condition is poor to fair, depending on location. Standing seam metal portion – age of material and last repair or detailed inspection unknown; significant rusting visible

Possible ridge beam sagging

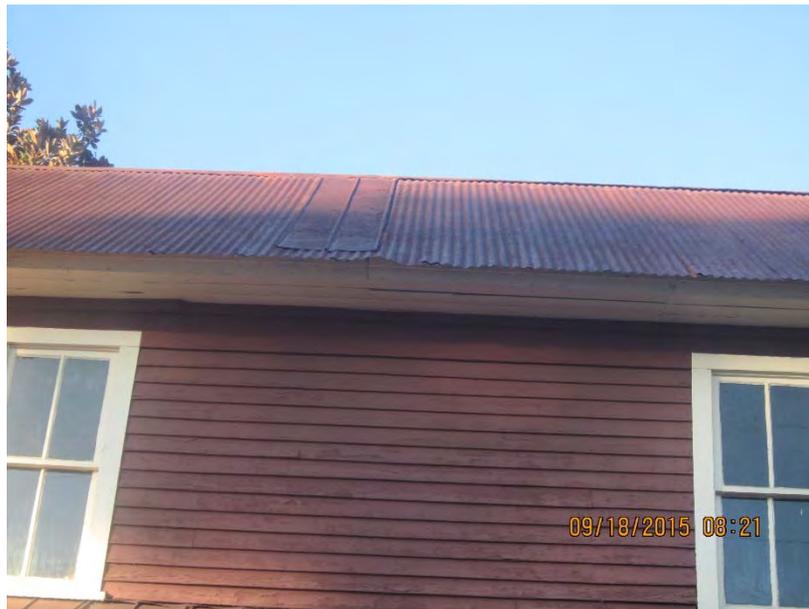
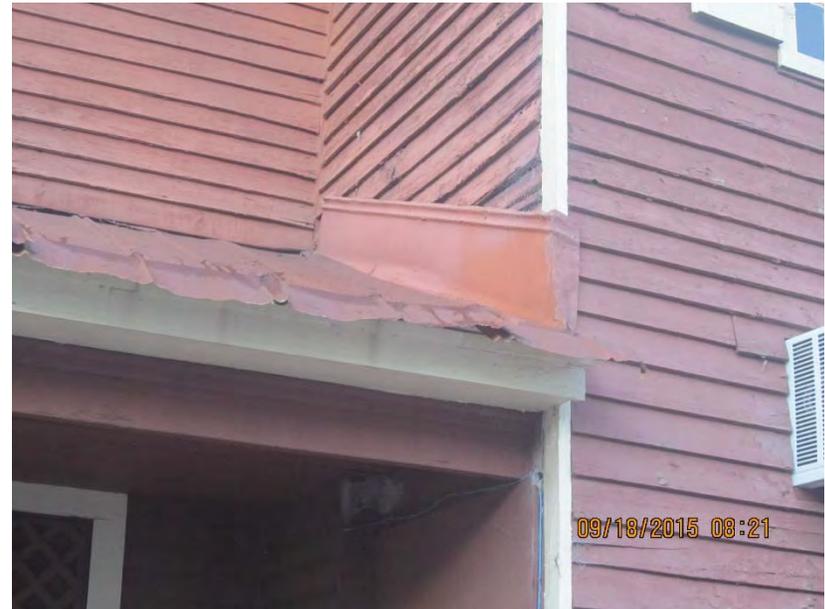
Section 1 Roof

Corrugated metal roof – age of material and last repair or detailed inspection unknown; holes, loose and/or missing fasteners; nails popped up, loose or sticking up above the sheet metal

Corrugated metal, nails

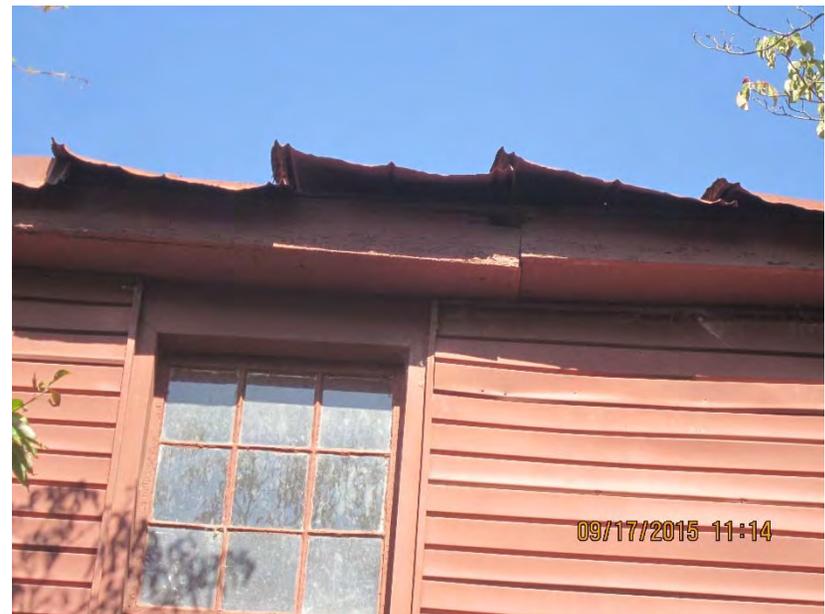
Section 1 Roof

There is moderate to severe wood rot and decay to fascia and eaves boards. Visibility of eaves board splitting and signs of deteriorated and wood rot. Flashing appears to be in poor condition with signs of leaking.

Deteriorated flashing

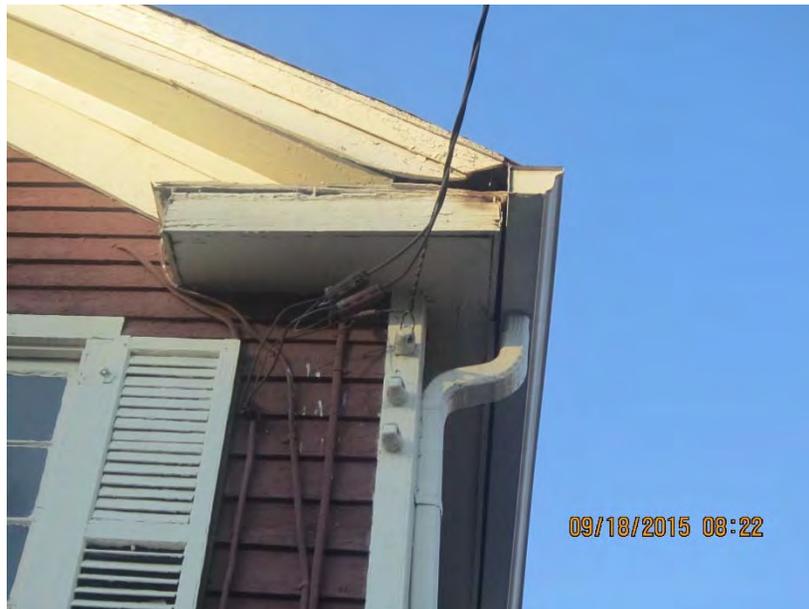
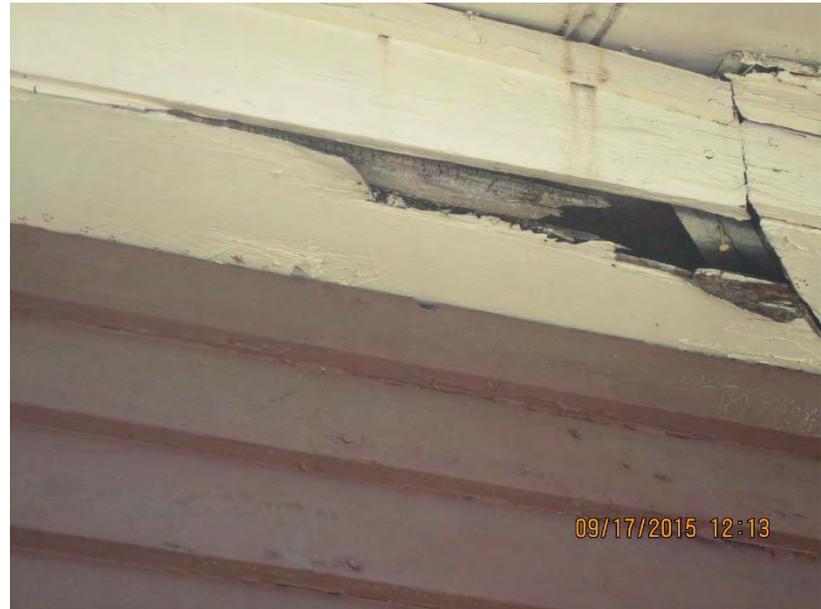
Section 1 Roof

Decay rotten wood on fascia boards

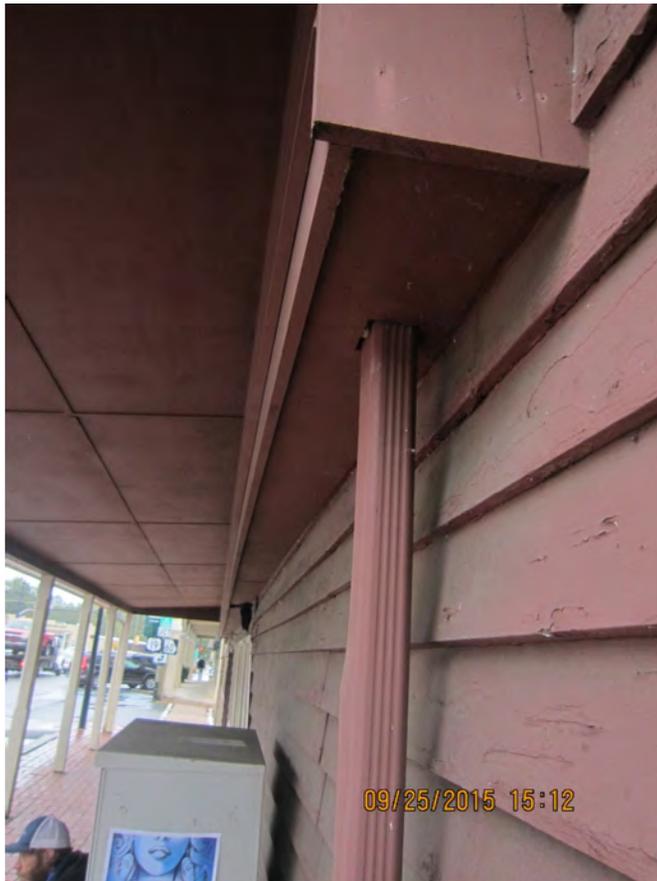
Section 2 Gutters and Downspouts

The front porch roof over the sidewalk also drains to an enclosed hidden gutter in the front face of the building – evidence of water damage and insect damage at interface; gutters and downspouts were not inspected for blockage and condition is not known. They should be cleaned to reduce potential for further water damage.

Gutter enclosed evidence of water and insect damage

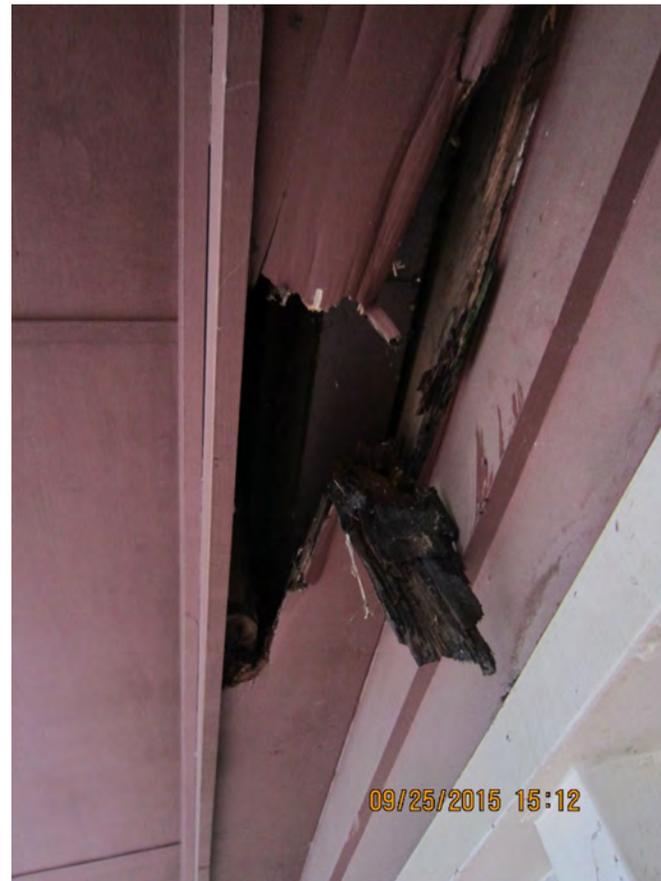
Possible water damage behind wall

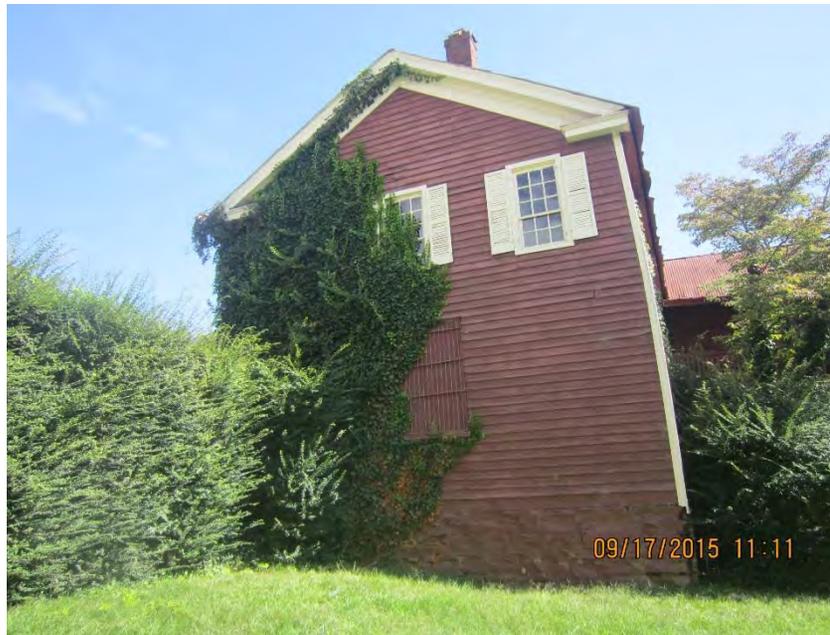
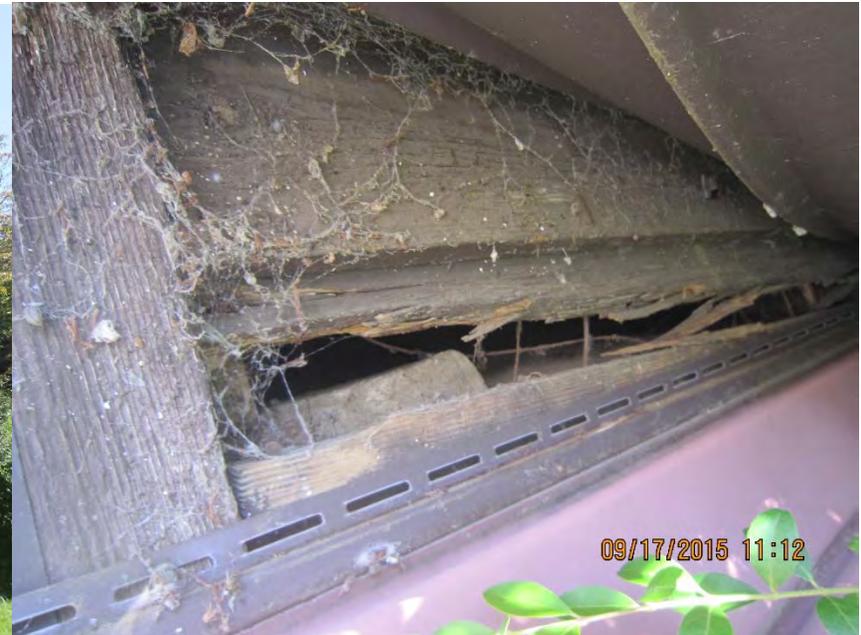
Section 3 Exteriors Walls

Overall condition of the exterior walls varies from very poor to good, depending on location. The western wall of the main building has large vegetation growing adjacent to and within the wall, which has caused significant damage. This should be removed to reduce moisture, root penetration, vermin and insect access.

Vegetation growing on exterior

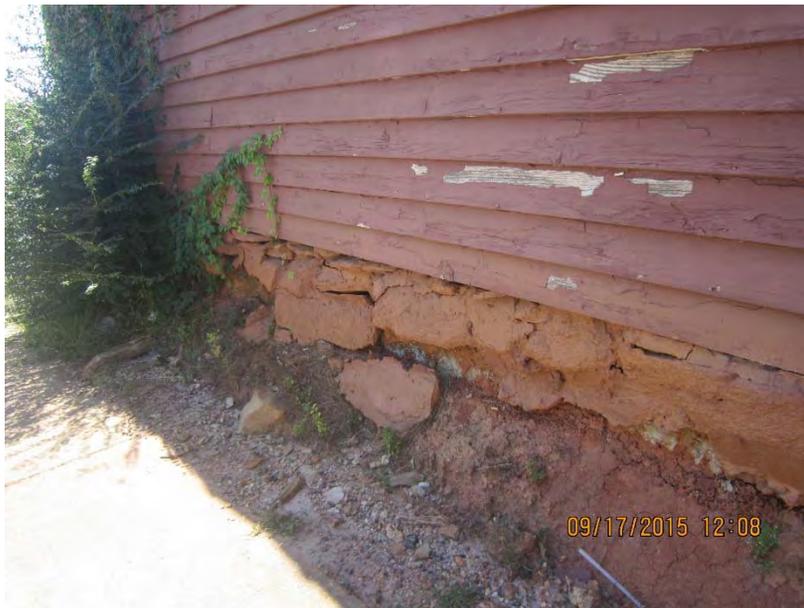
Section 3 Exteriors Walls

Deterioration of siding and foundation

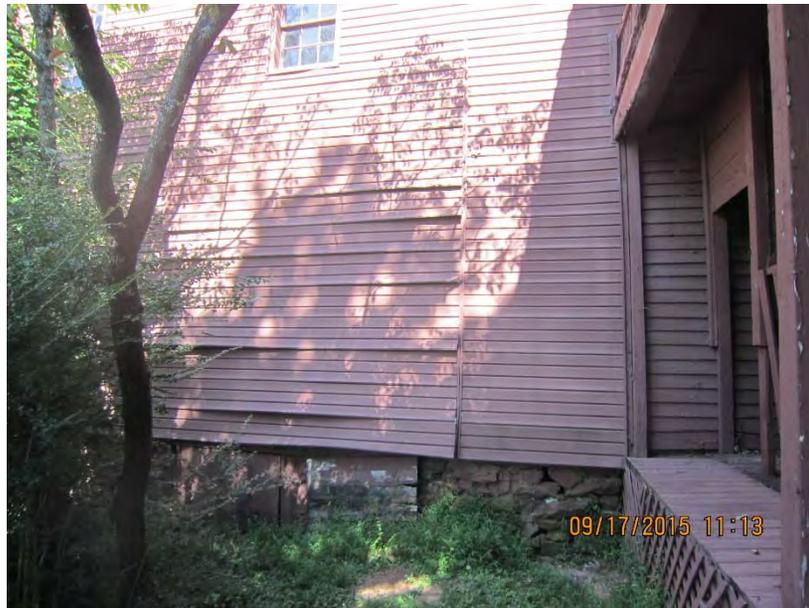
Section 3 Exterior Walls

Vinyl siding on one back wall

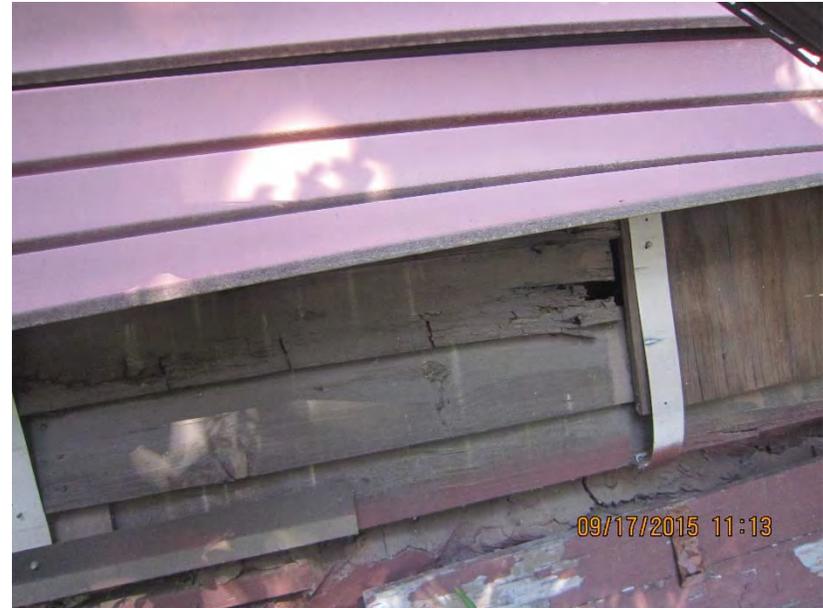
The walls bulge in several locations with significant variation in condition of visible and covered wood siding material; significant deterioration at ground level for much of the structure and in the southwestern wall (area covered by vinyl siding)

Deterioration of wall underneath the vinyl siding

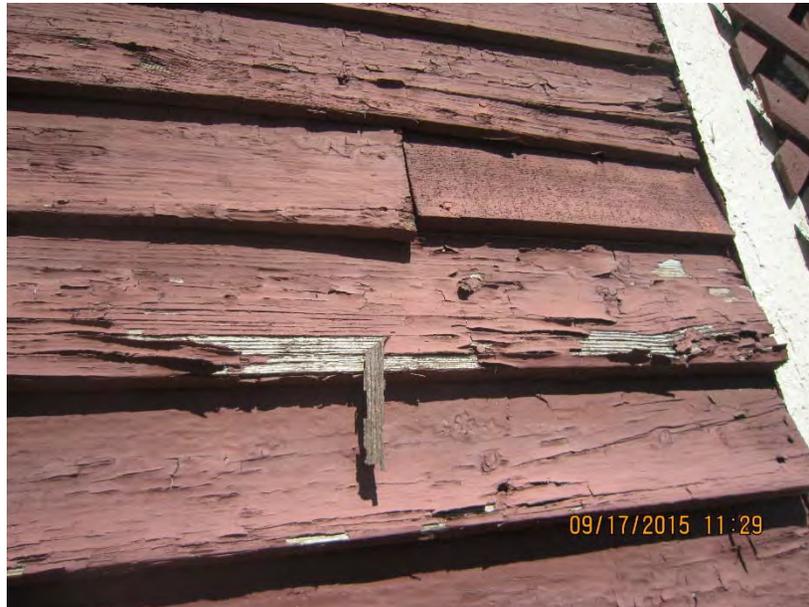
Poor condition of clapboard siding

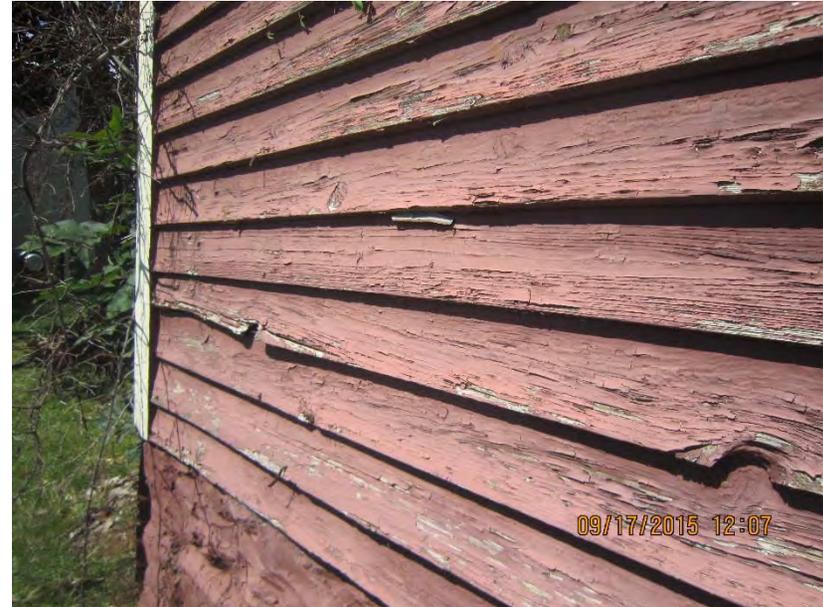
Severe paint peeling, blistering and cracking is present over all walls; paint not tested for lead content; much of the building may have been unpainted for much of its life because of the thin paint layer.

Peeling, blistering and cracking of paint

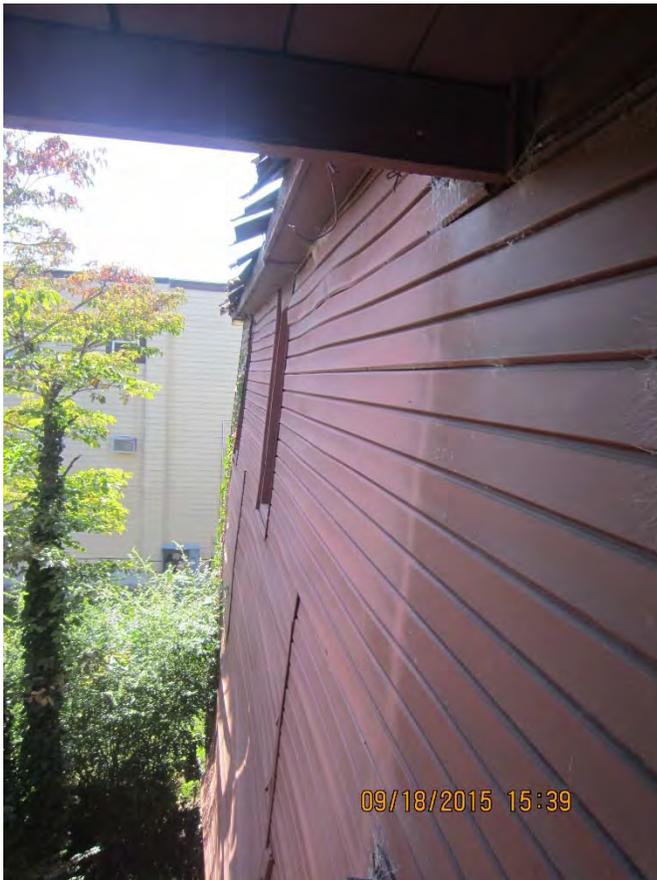
Exterior wall leaning

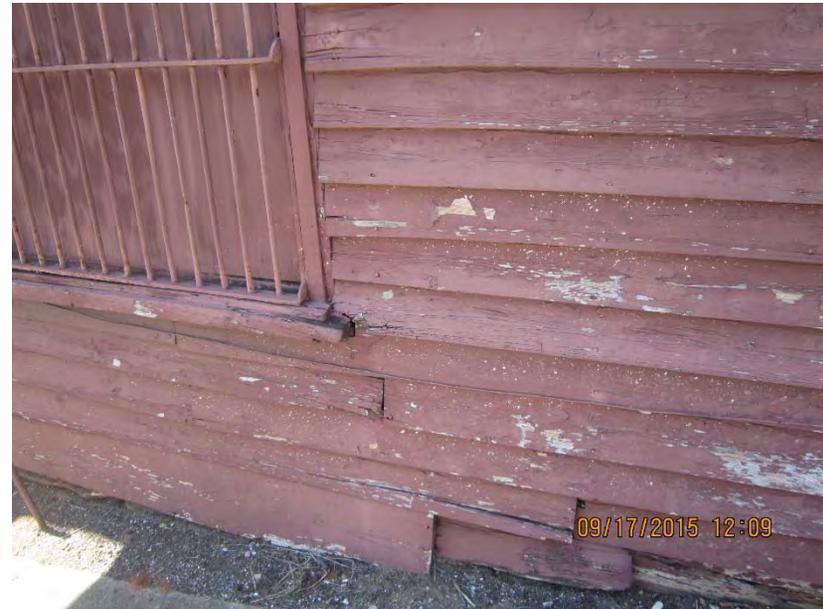
Deteriorated siding

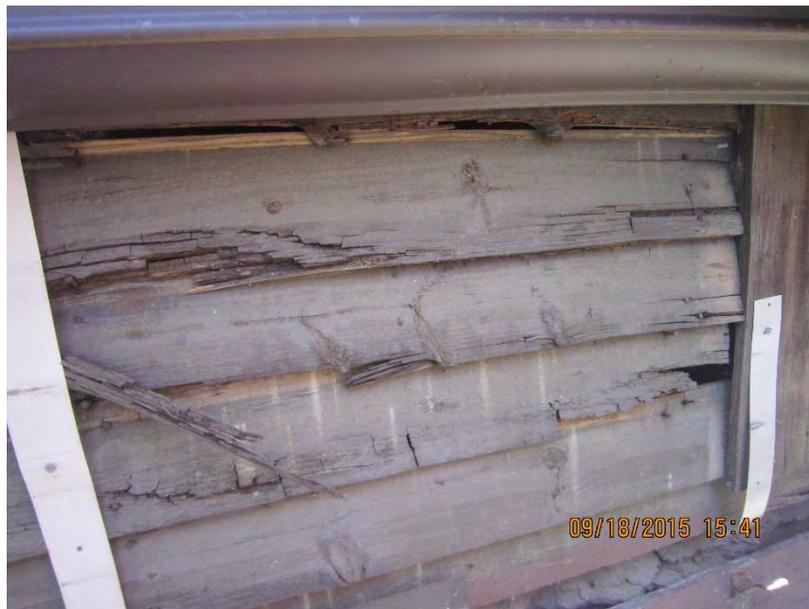
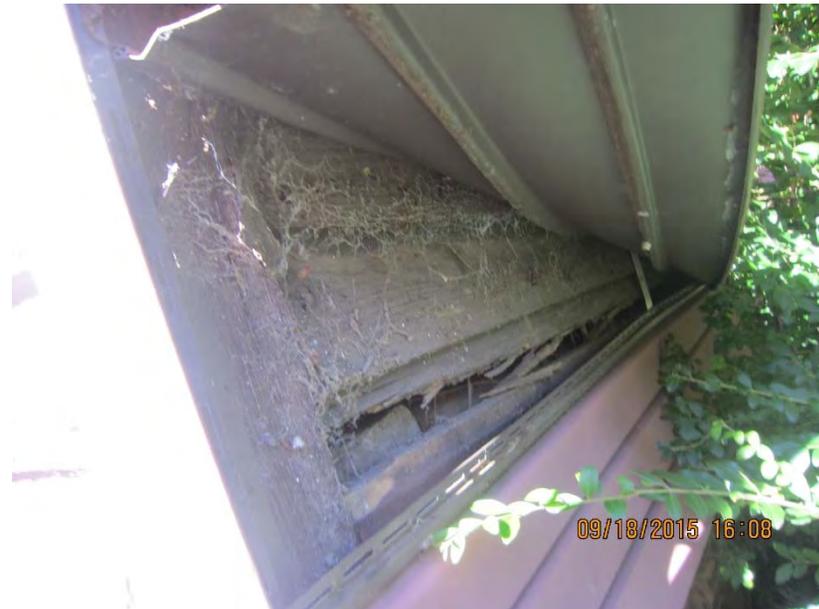
Deteriorated siding

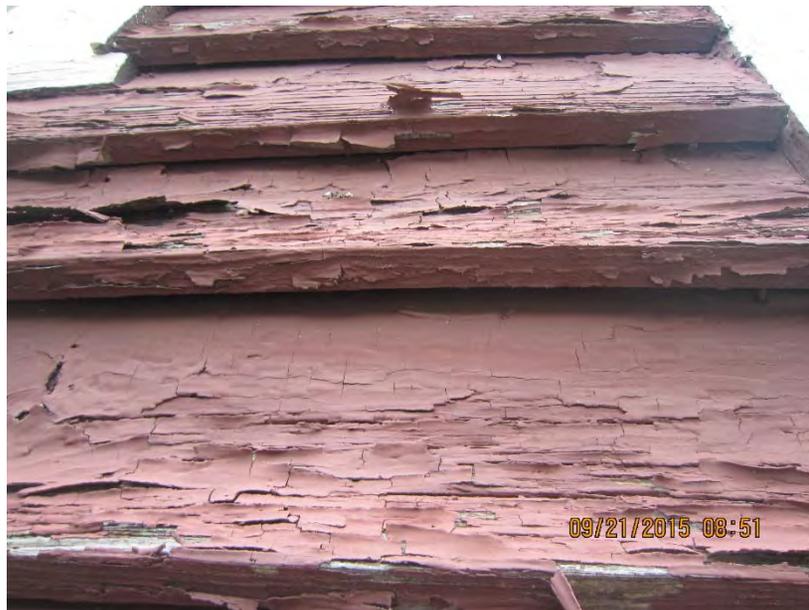
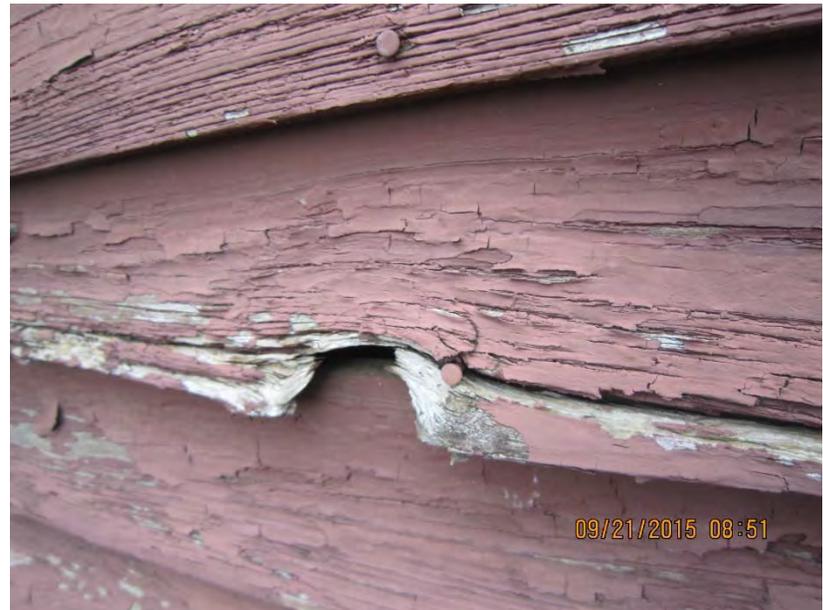
Rotten siding

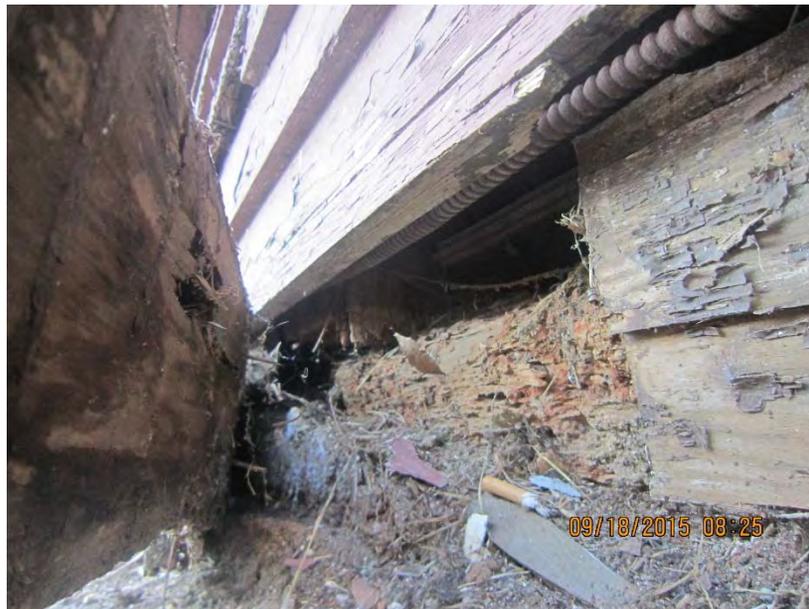
Sill plates rest on bare dirt with significant insect damage and wet/dry rot. This has transferred into many lower level pieces of siding and likely into wall studs.

Sill plate on bare dirt, insect damage, rotten floor sill on east side of building

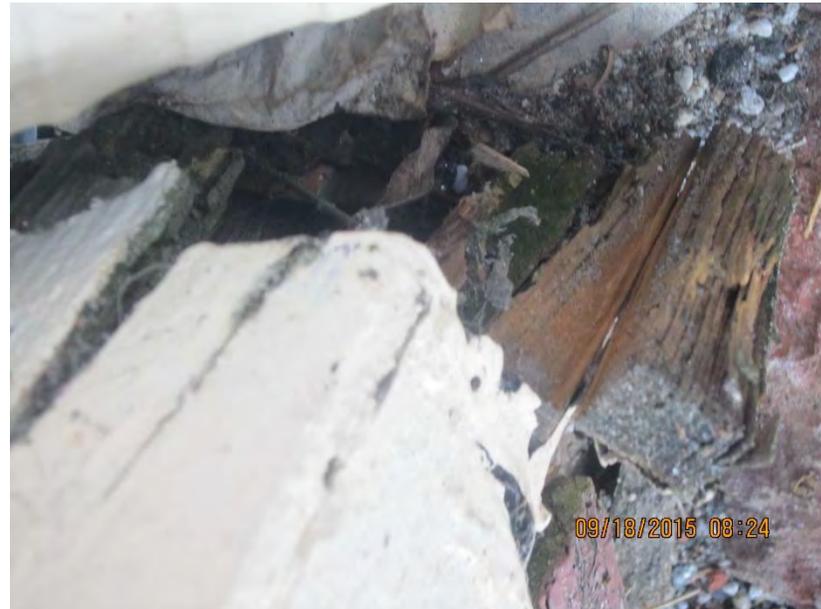
Insect damage, rotten floor sill Meaders St. Side

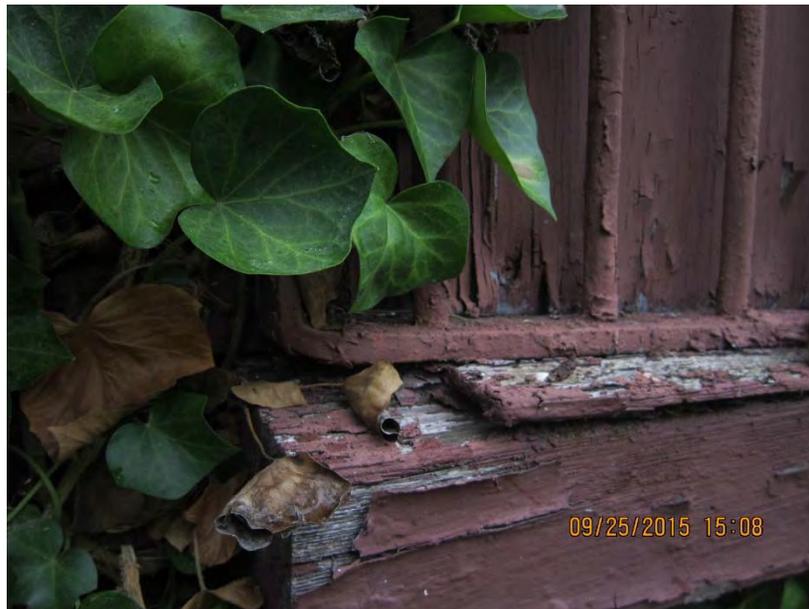
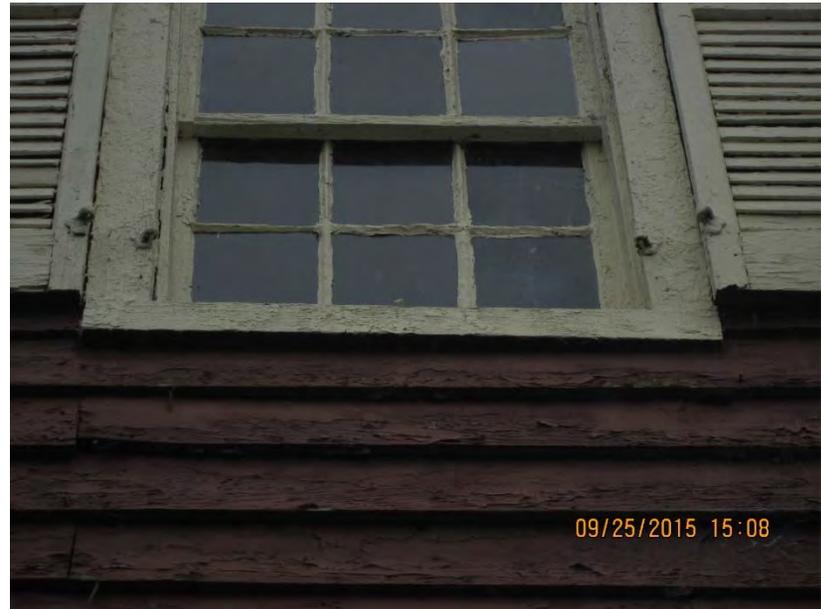
Some exterior siding below windows is deteriorated from insect damage and wet/dry rot. This has likely transferred rotted sills

Siding deteriorated under window

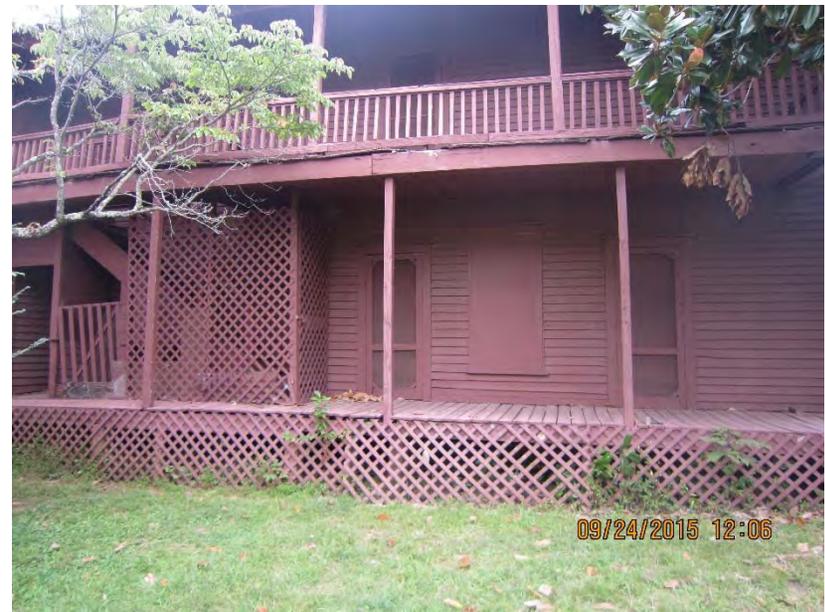
Rear Entry

The rear of the building adjacent to the parking lot is from a short set of three concrete steps without handrail. The steps are not ADA compliant. This location appears to have the greatest potential for creation of ADA compliant access. A large magnolia tree is adjacent to the steps and lower porch and should be removed to prevent root damage and access to the porches, roof and attic of the building by squirrels and insects.

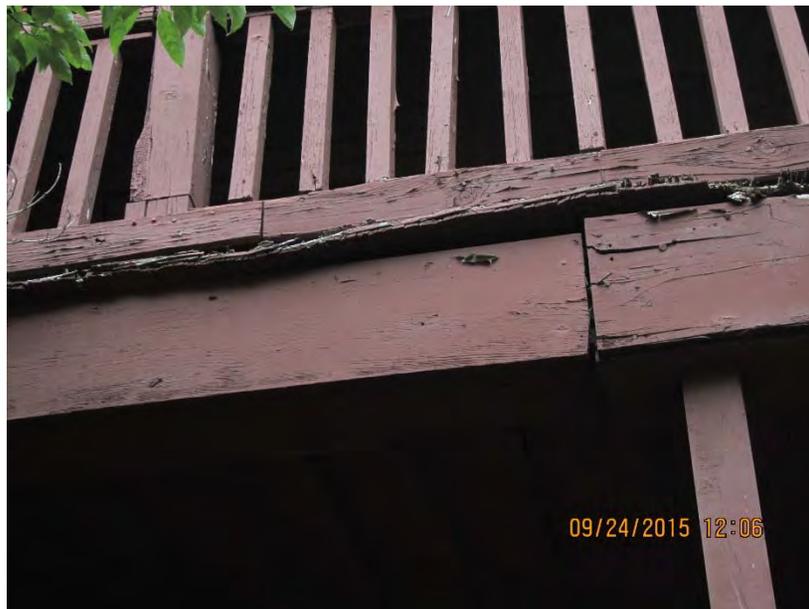
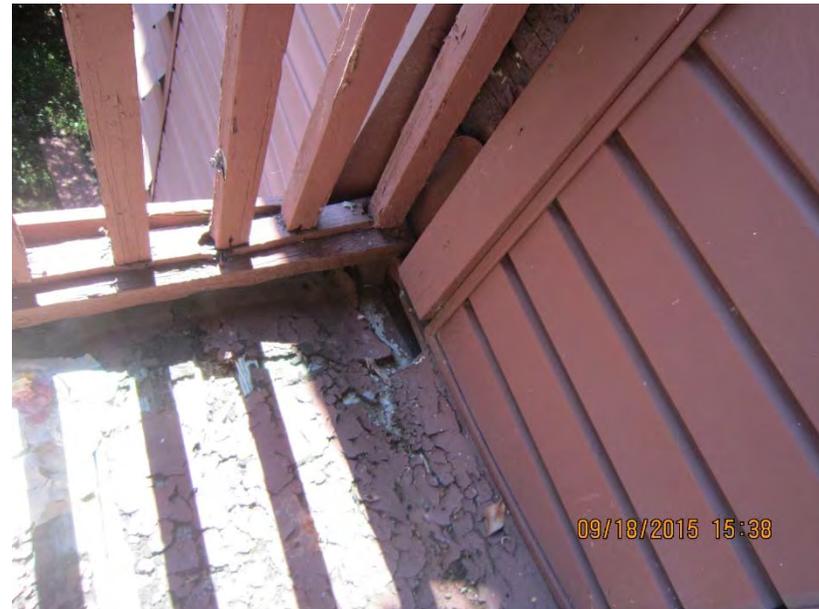
A single set of exterior wooden stairs joins two porches on the rear portion of the building and provides access to the second floor of the building. If there was ever internal stairway access in the main building, its location cannot be easily determined. The outside stair treads are in relatively good repair and do not appear to be well worn. However, the porches are severely deteriorated and the stair risers need to be reset. The upper rear porch has a dangerous slope and requires complete reconstruction.

Upper Rear Porch Deterioration

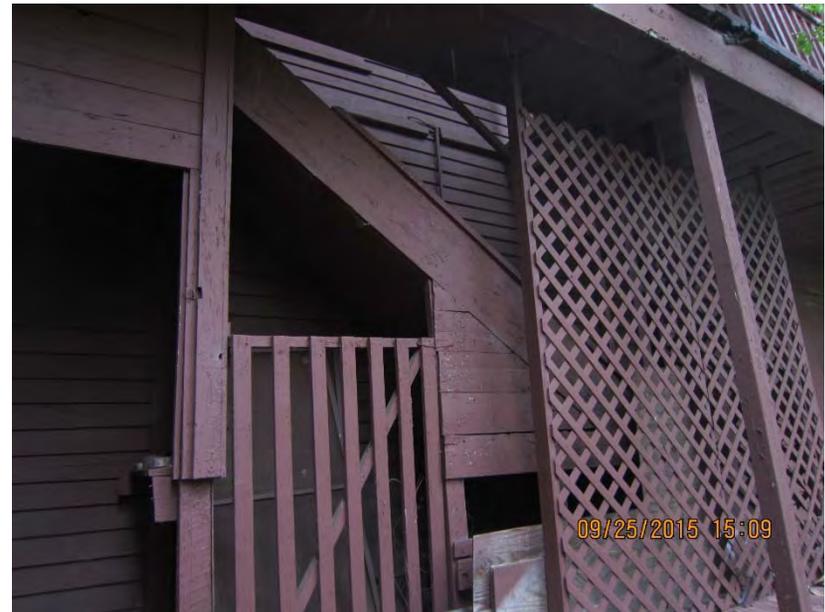
Stairways are deteriorated and need to be replaced.

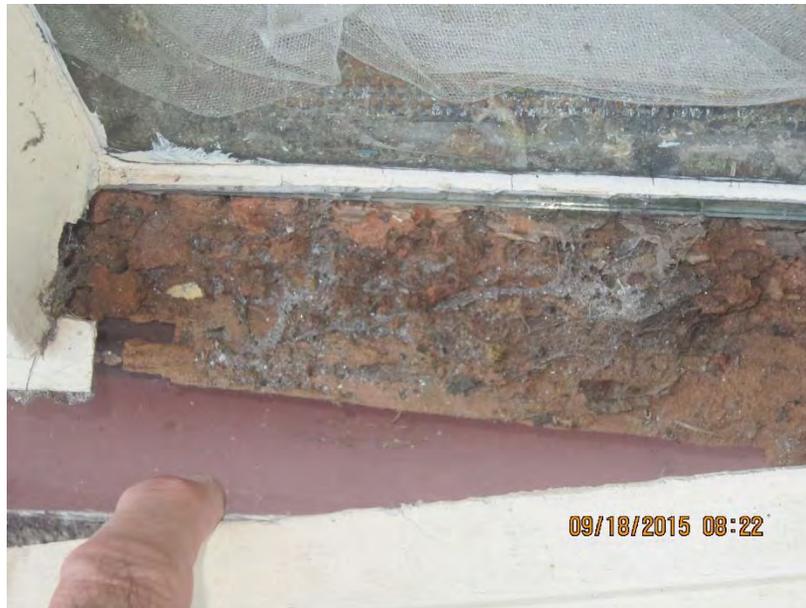
Front lower level window sill

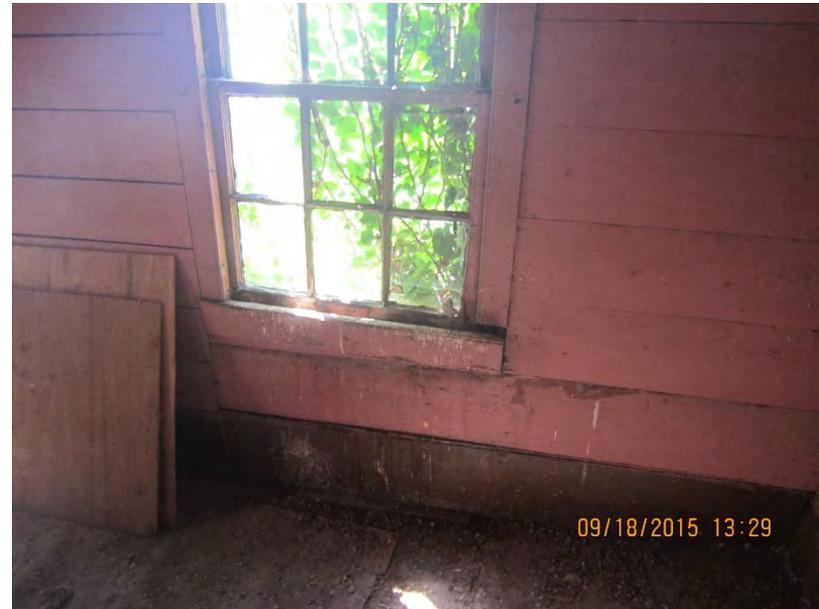
The upper floor of the main building has inoperable wooden windows with wooden shutters and hardware. These are 9 over 6 lite sashes and appear to be double-hung. More than one is permanently open, resulting in significant damage and rot to the sill and both floors below with long present water damage on interior walls (west and south side). Much of the glazing on the windows is missing. The condition of sash cords and weights was not determined as all windows appear to be painted shut or inoperable because of alignment problems from wall shift.

Upper window deterioration

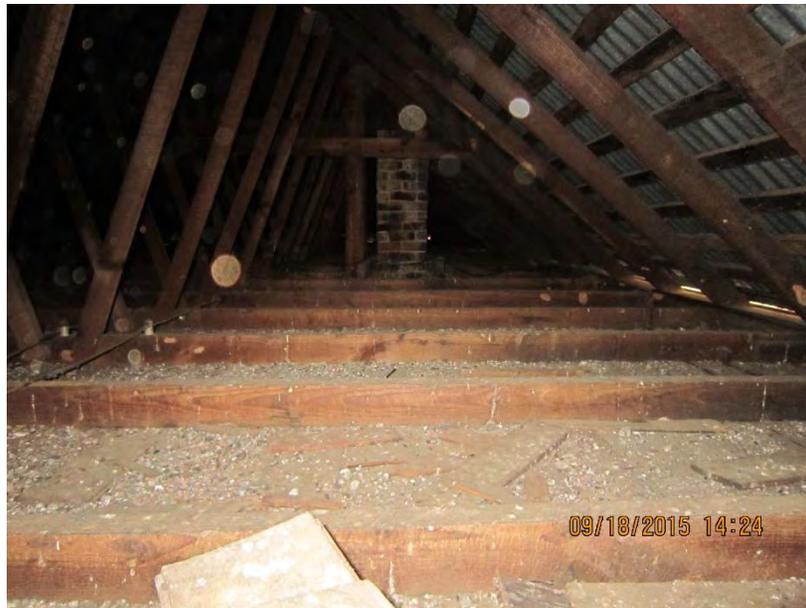
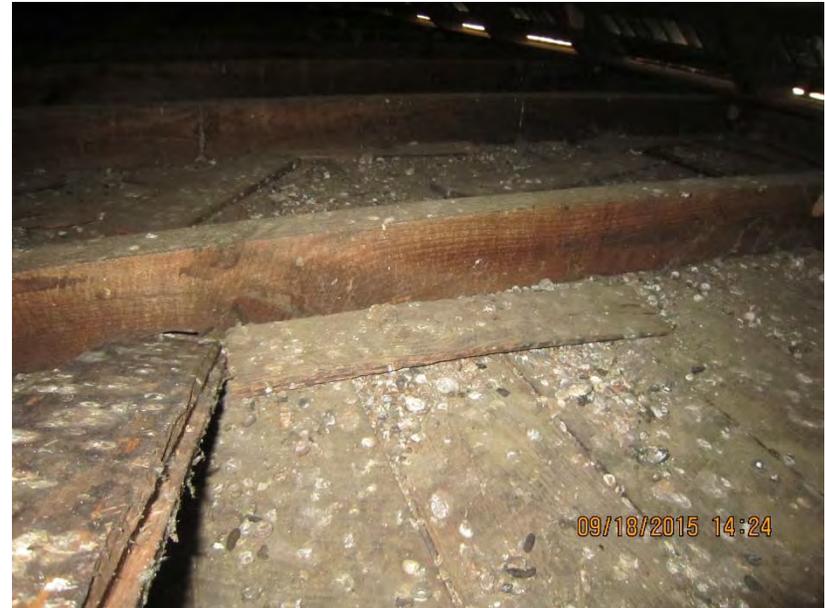
Section 6 Attic

There is evidence of water leaks in several locations and extensive bird and vermin infiltration.

Extensive bird and vermin infiltration

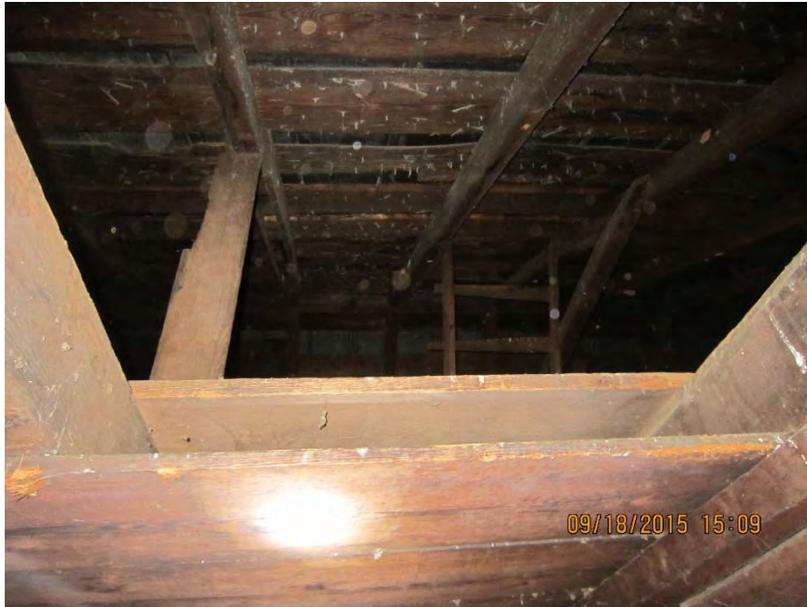
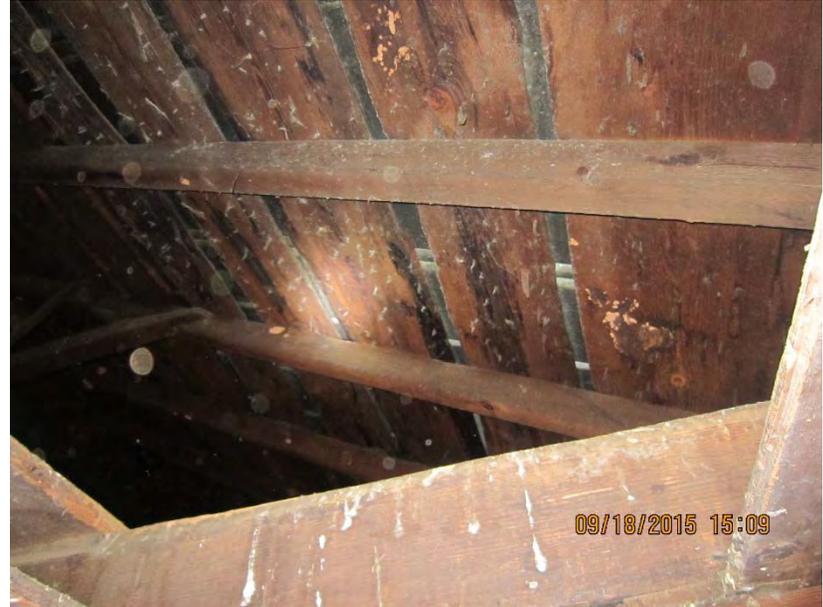
Water damage

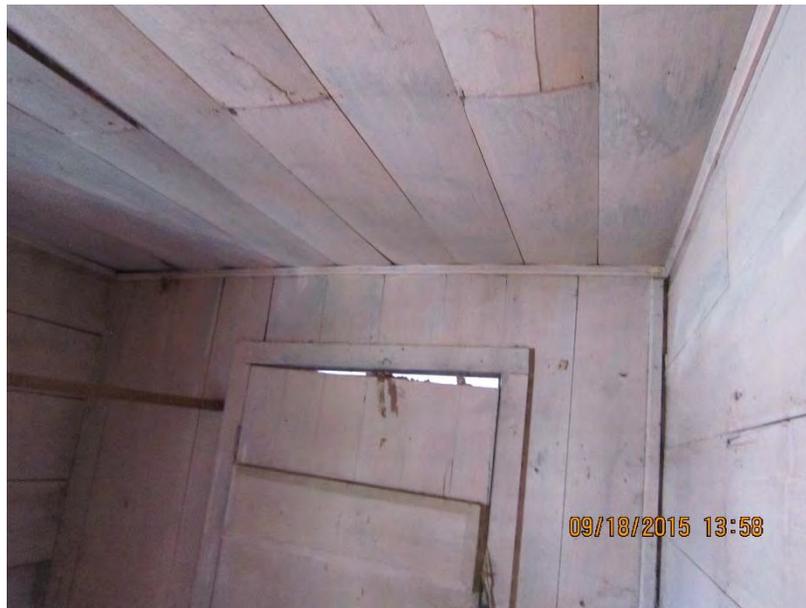
Section 7 Interior

The interior of the main building is rough with noticeable floor sag/bounce on the ground floor, sagging ceilings with walls and doors out of alignment with sticking/binding of doors and uneven settling.

Sagging ceiling, misaligned doors

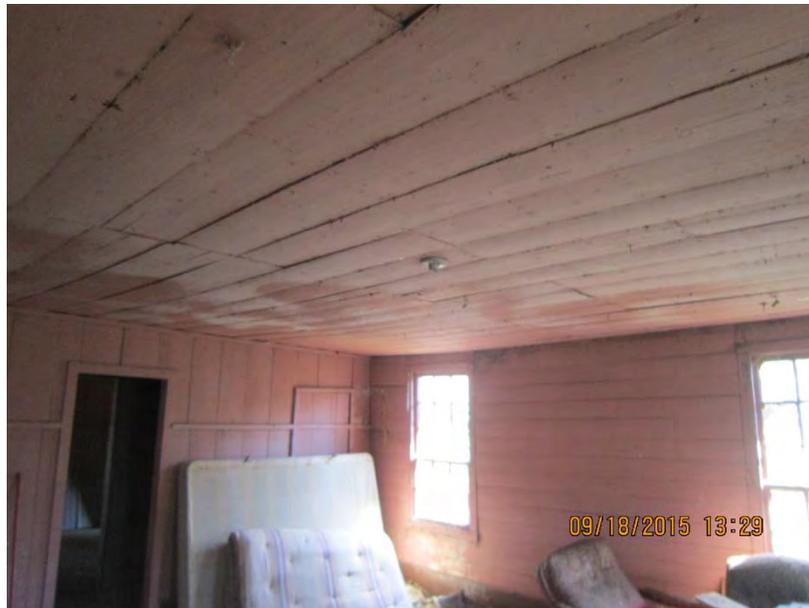
Sagging ceiling and

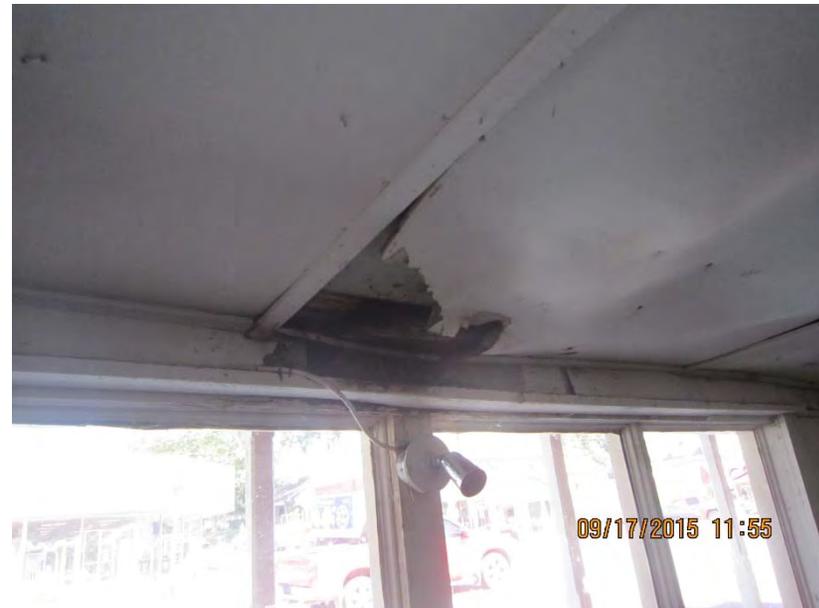
Water damage

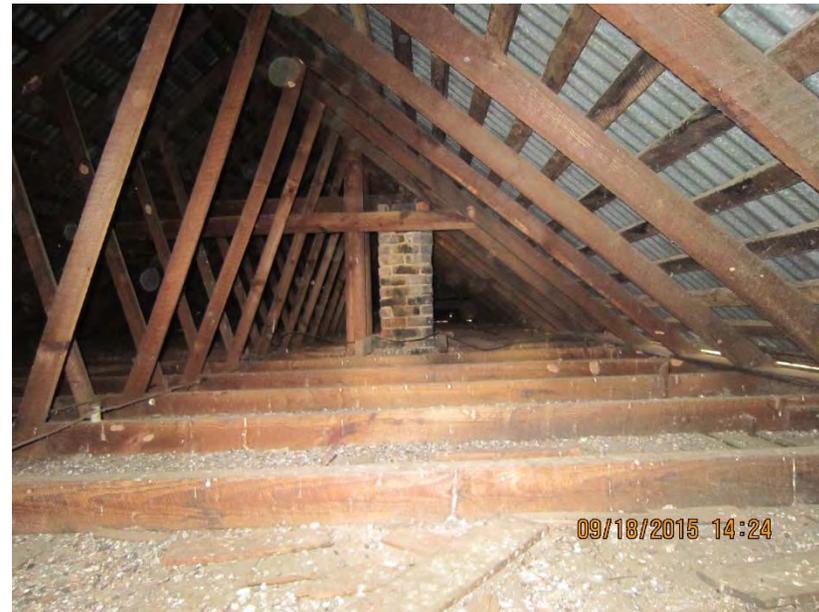
Chimney in attic

The apparent chimneys outside are really just stove pipe flues. There are no fireplace fireboxes, hearths or evidence of prior mantels on either floor.

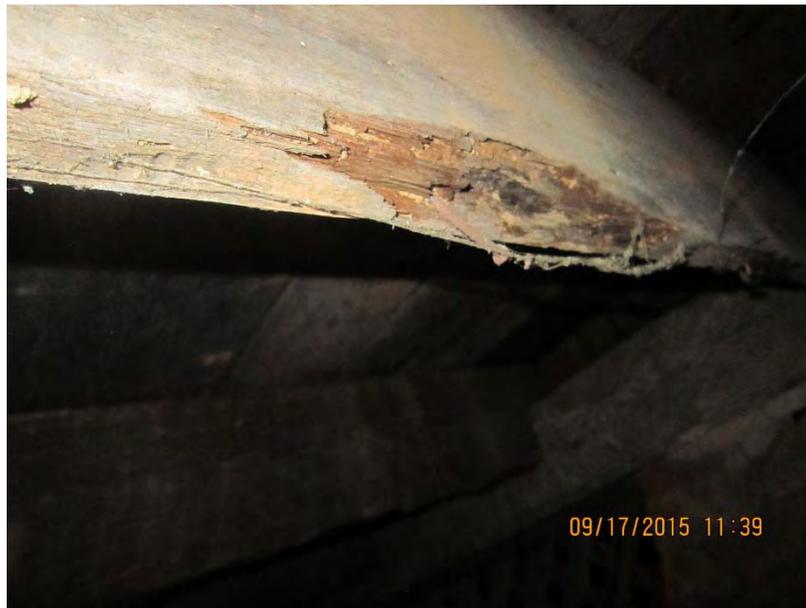
Section 8 Foundation

Subfloor shows prior collapse and current significant break in main girder beam paralleling East Main under the main building. Virtually all replacement floor joists made from cedar trees or heart pine laid lengthwise from the main beam to the sill plates show significant damage from borer beetles along their entire length. Small piles of sawdust/wood debris exist in numerous places.

Floor joist damage

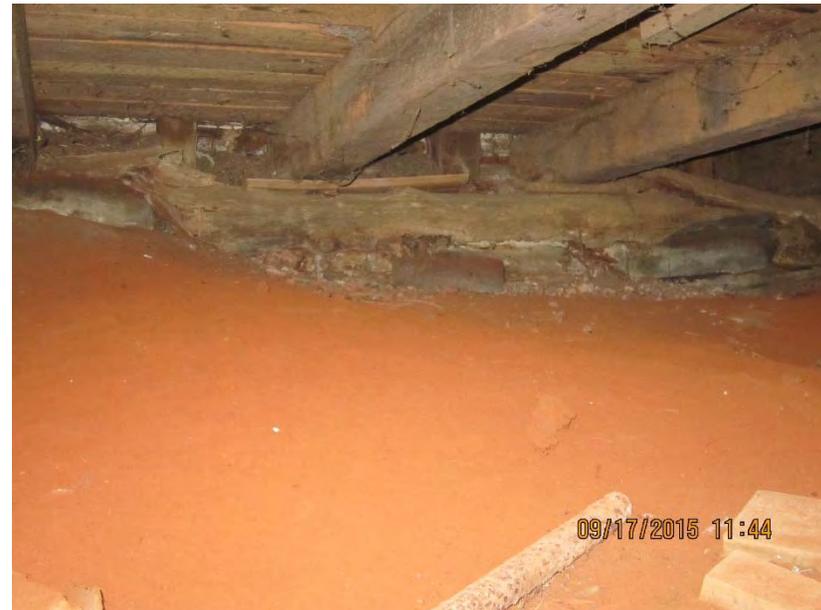
Rotten Sill plate, joist resting on ground

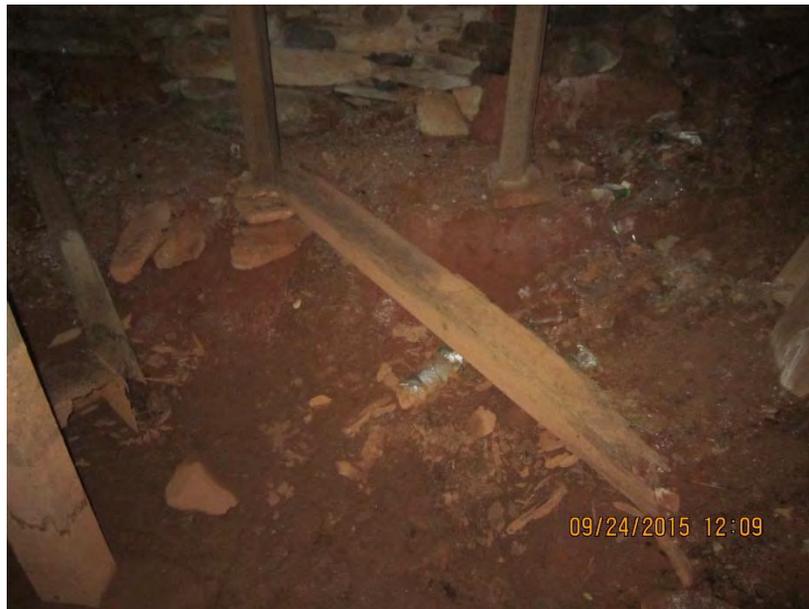
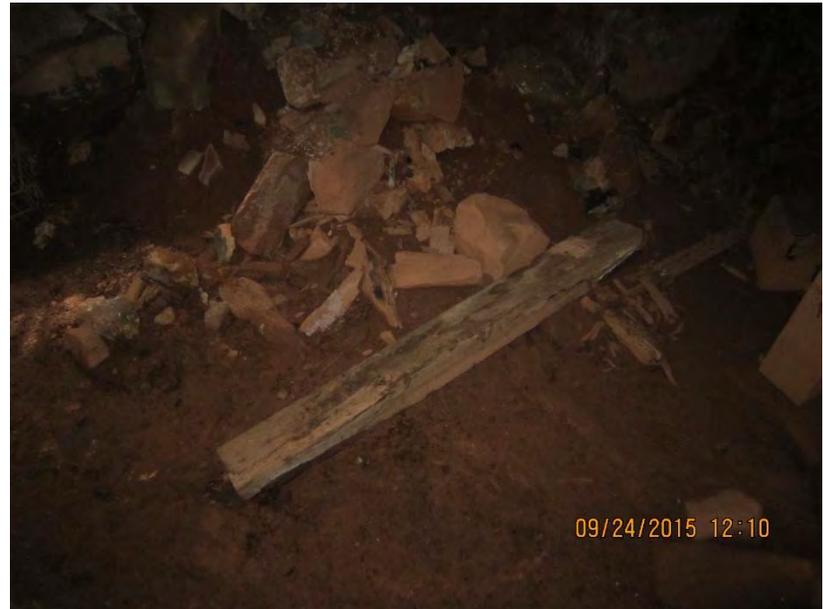
Deteriorated wood on ground
