CONDITION ASSESSMENT REPORT WITH PICTURES

40 East Main

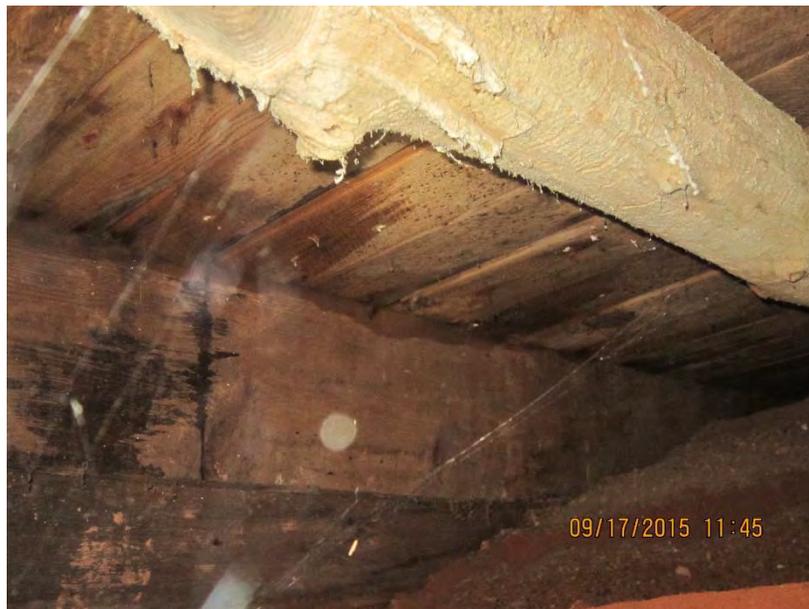
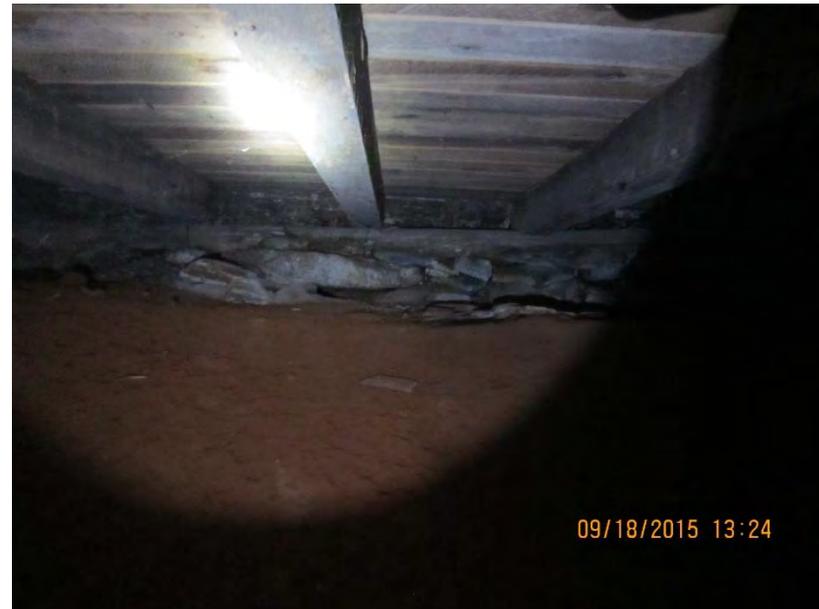
Water and wood rot damage

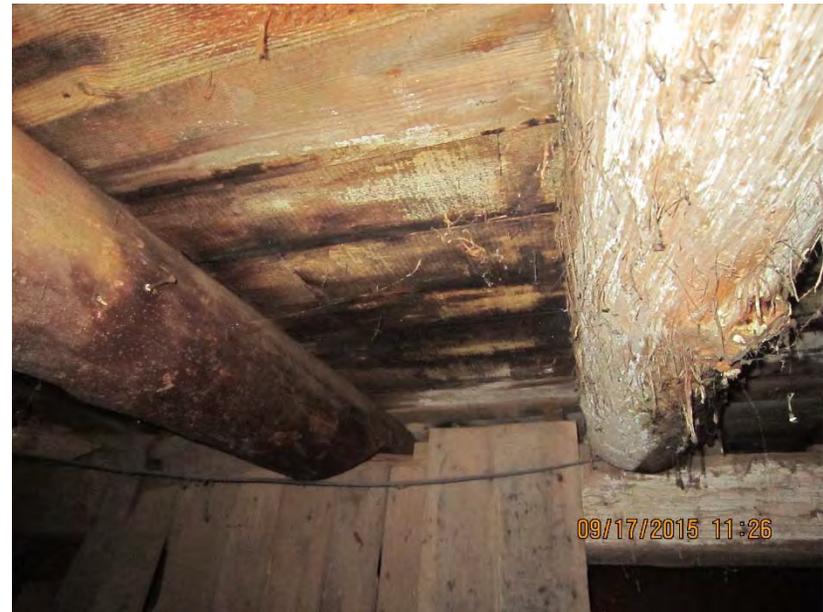
Water damage and wood rot

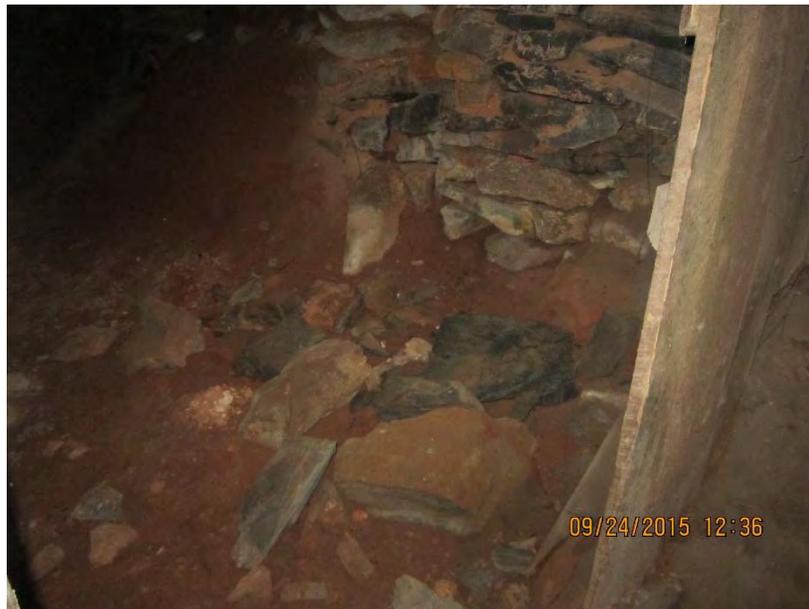
Vertical cracks, spalling, crumbling and deterioration in the stone masonry foundation with some missing stone. Temporary shored bracing appears inadequate to support dead or live load for occupancy.

Crumbling, deteriorated stone foundation

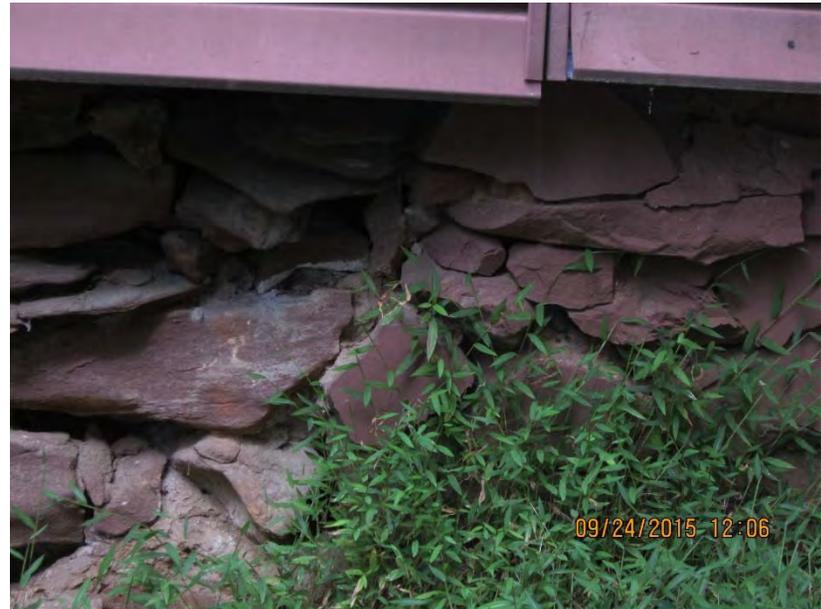
Exterior foundation holes and gaps

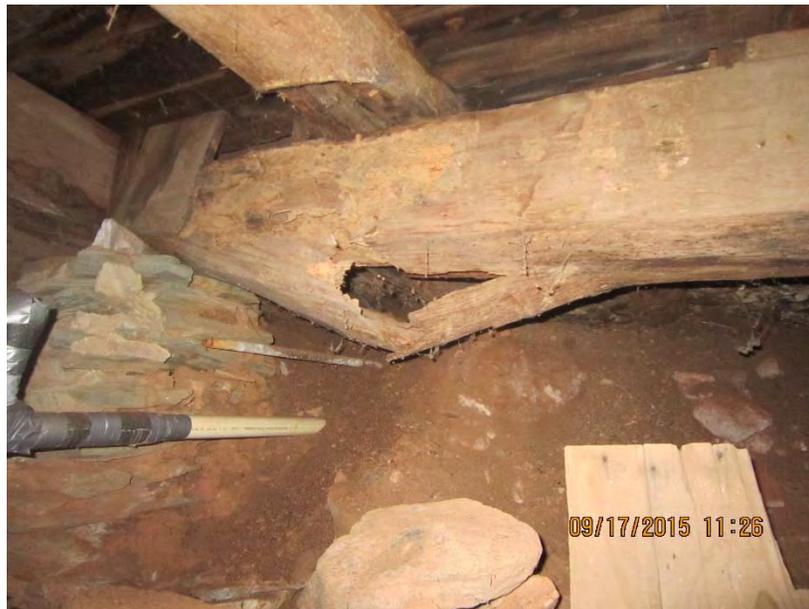
Subfloor shows prior collapse and current significant break in main girder beam paralleling East Main under the main building. Virtually all replacement floor joists made from cedar trees or heart pine laid lengthwise from the main beam to the sill plates show significant damage from borer beetles along their entire length. Small piles of sawdust/wood debris exist in numerous places.

Break in center girder beam support

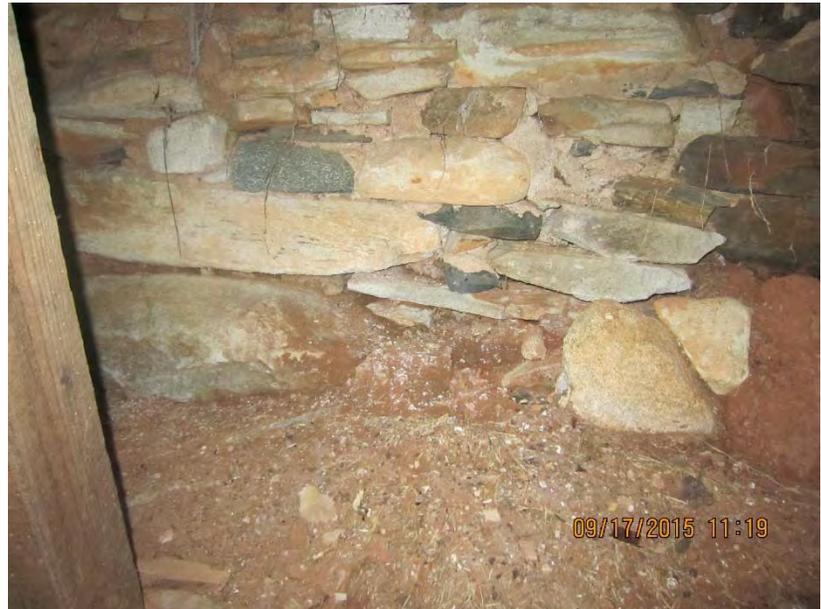
Crumbling foundation

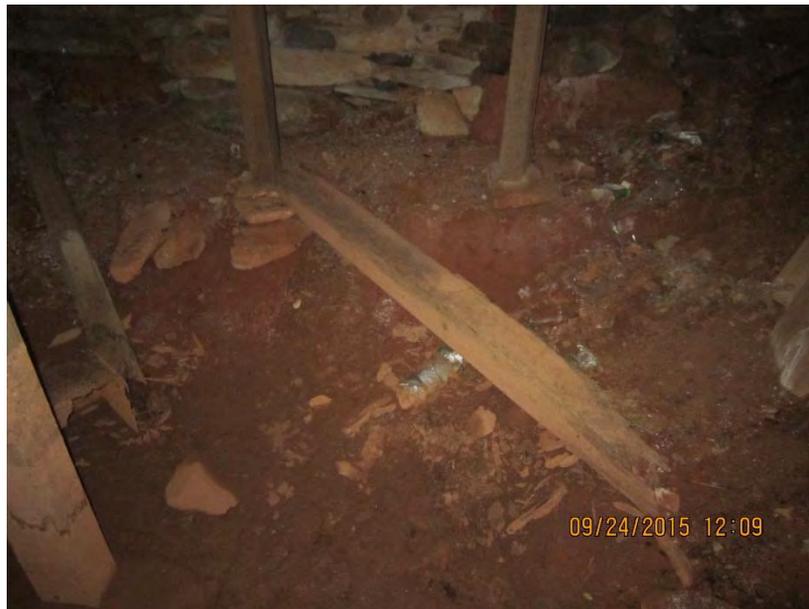
Beams failing

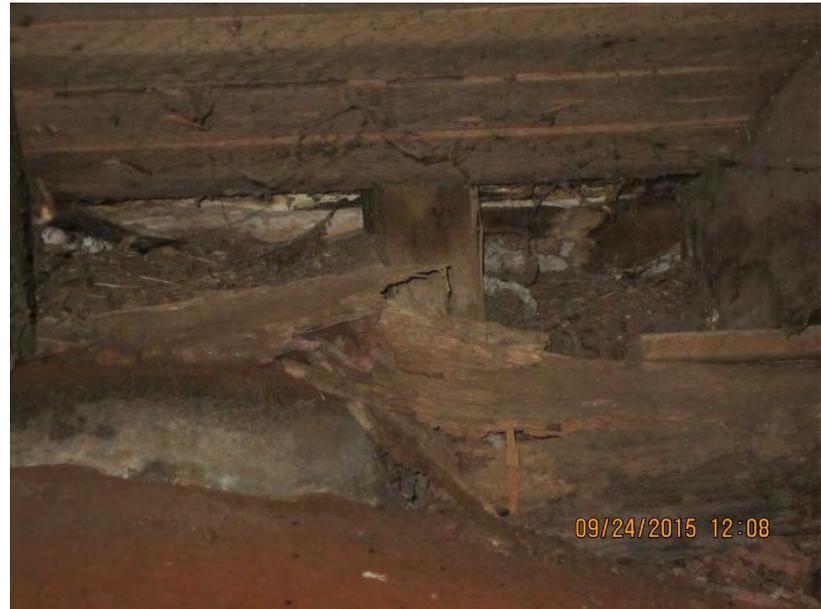
Insect, wood rot of sill plate

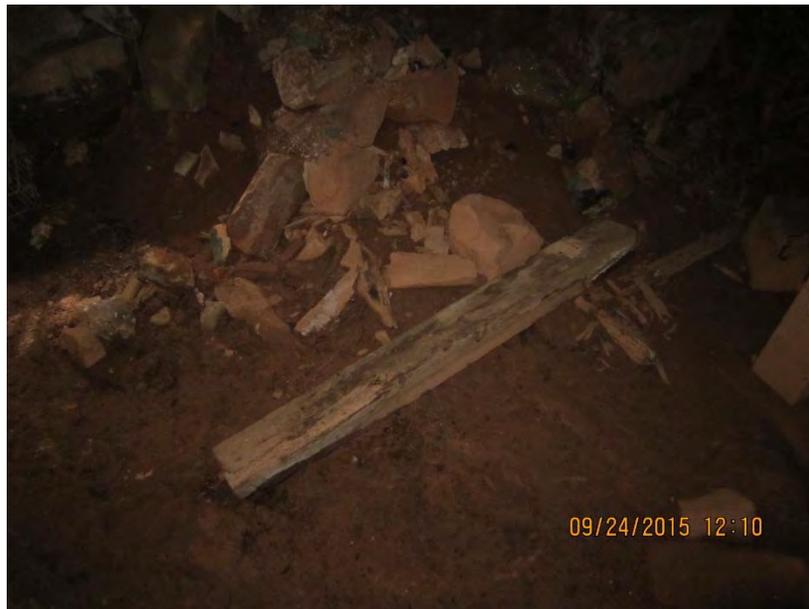
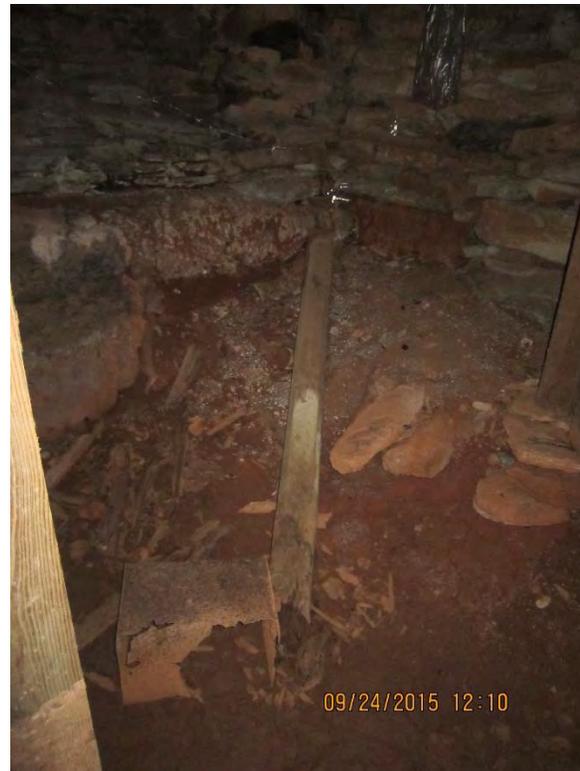
Beams failing

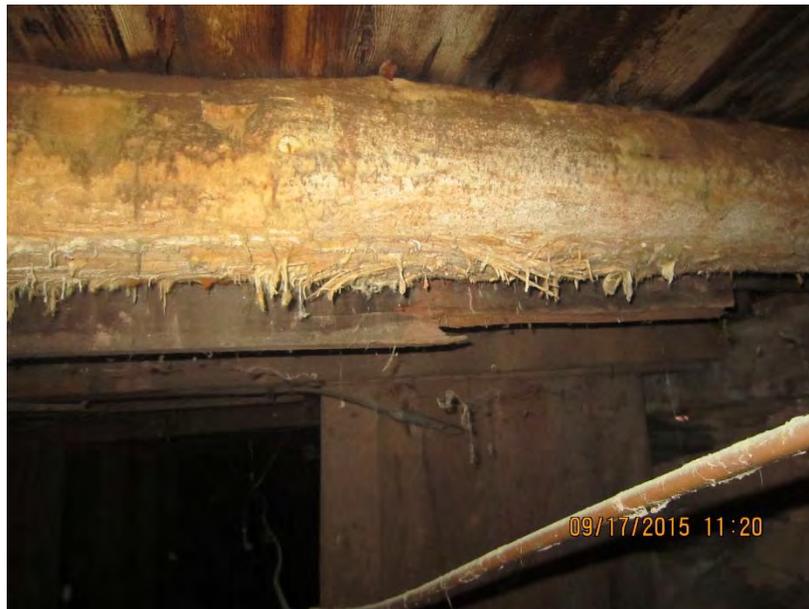
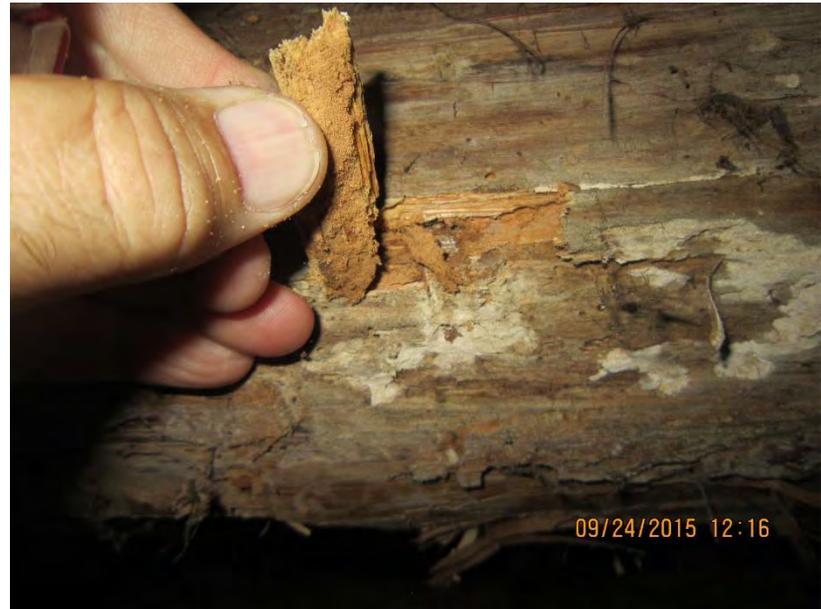
Floor joist rot and inset damage

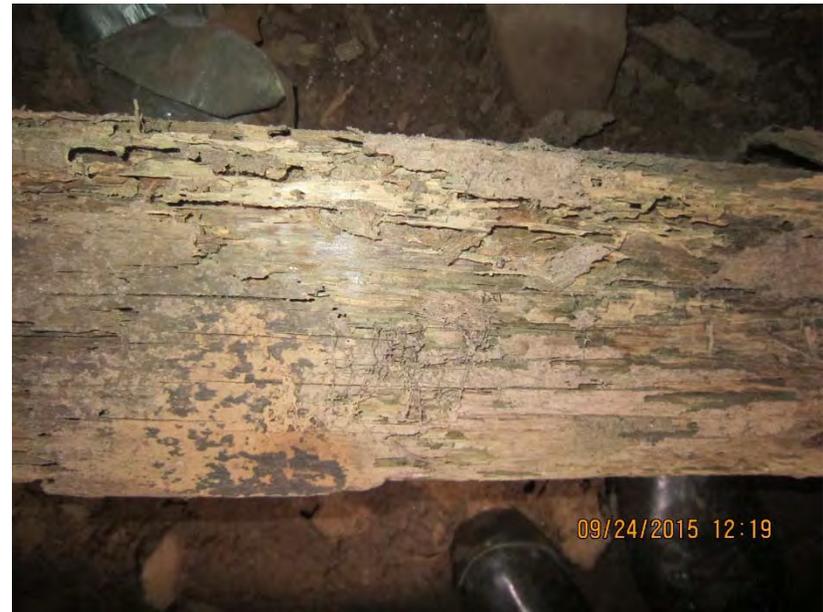
Signs of Termite Damage

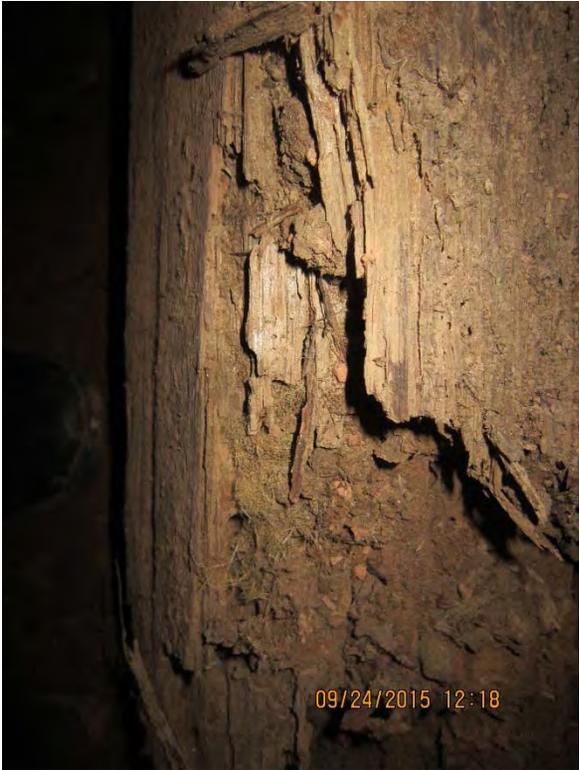
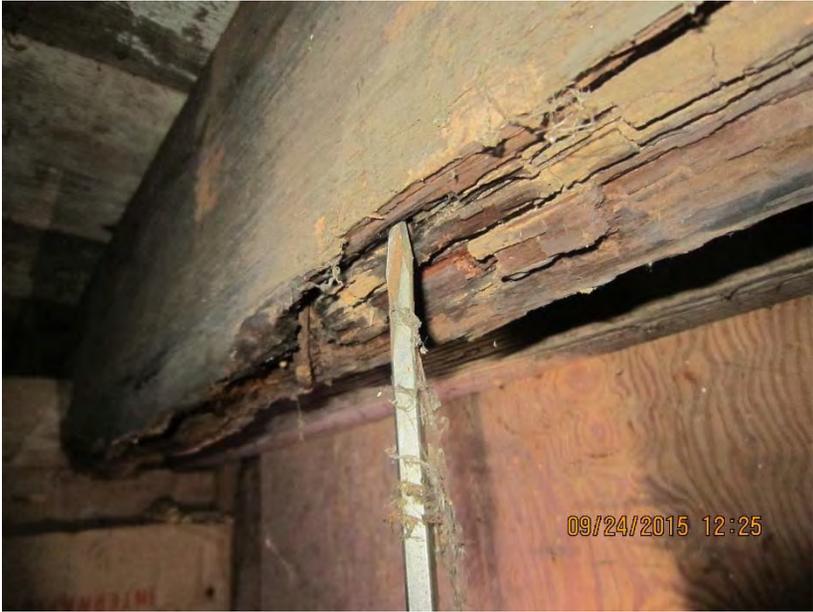
Wood rot

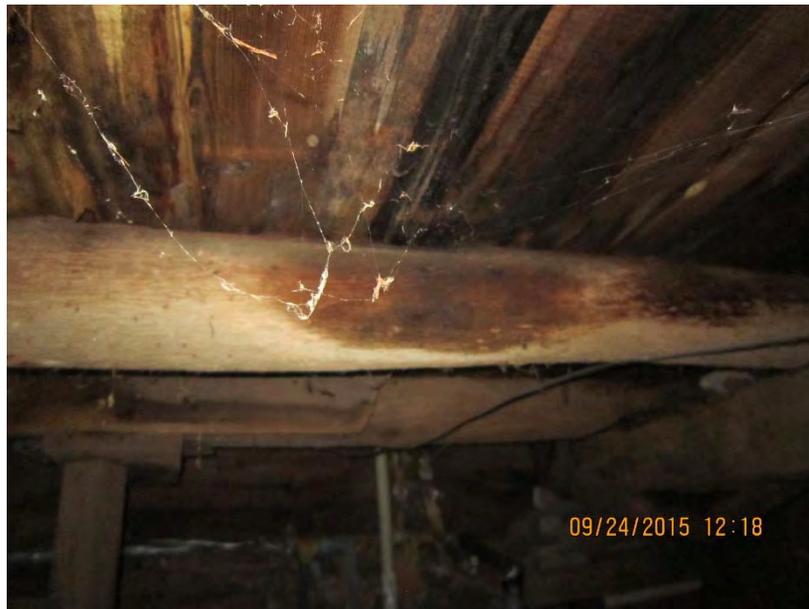
Water damage on sub floor

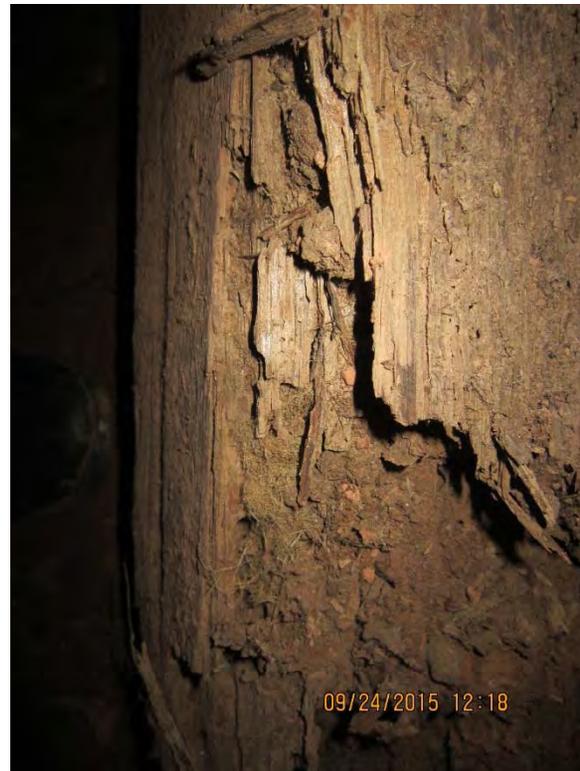
Wood rot on support post

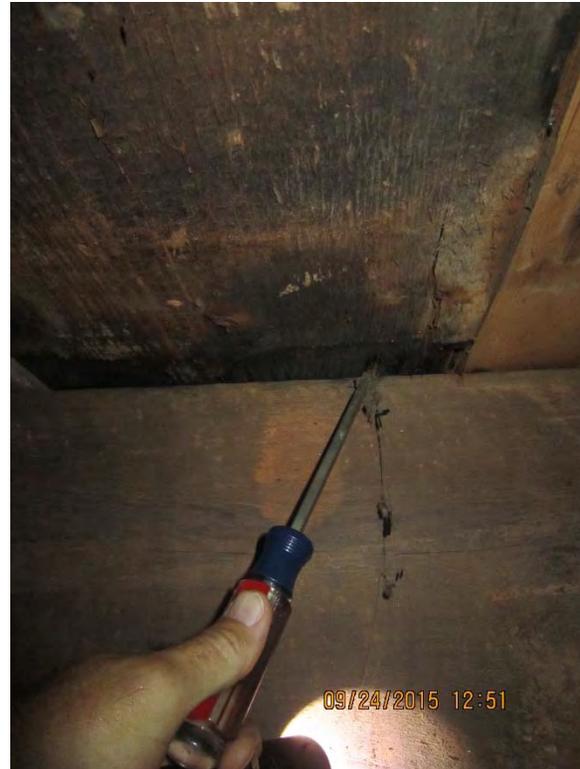
The lower floor decking above the subfloor shows rot, water damage and moisture.

Lower Floor Decking water damage

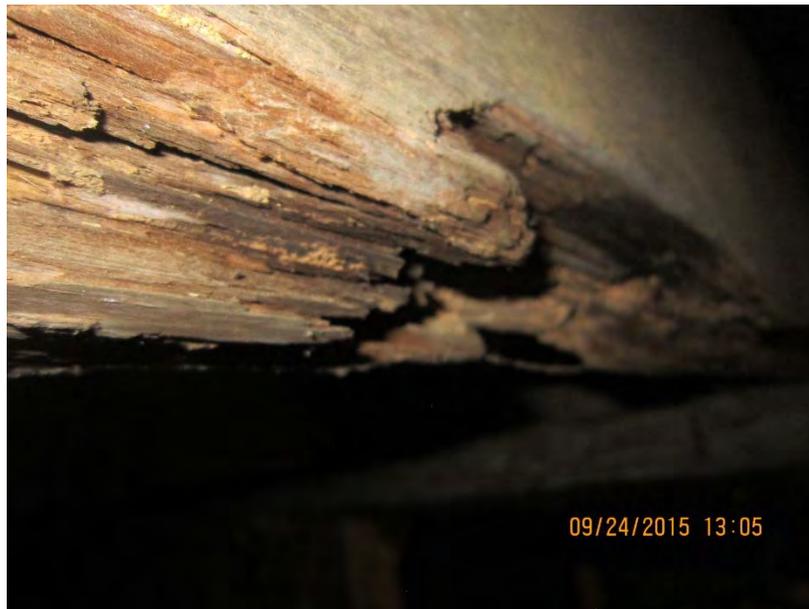
Deteriorated floor joist

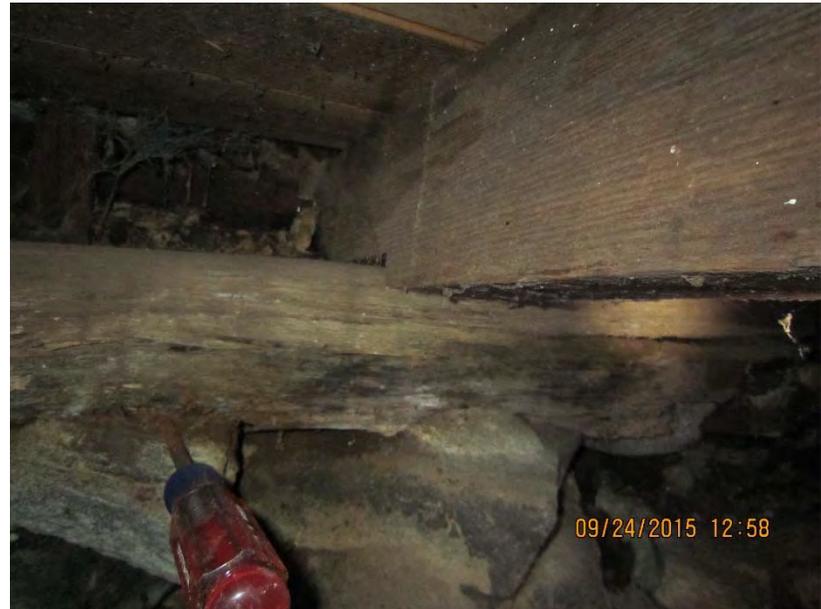
Deteriorated sill joist

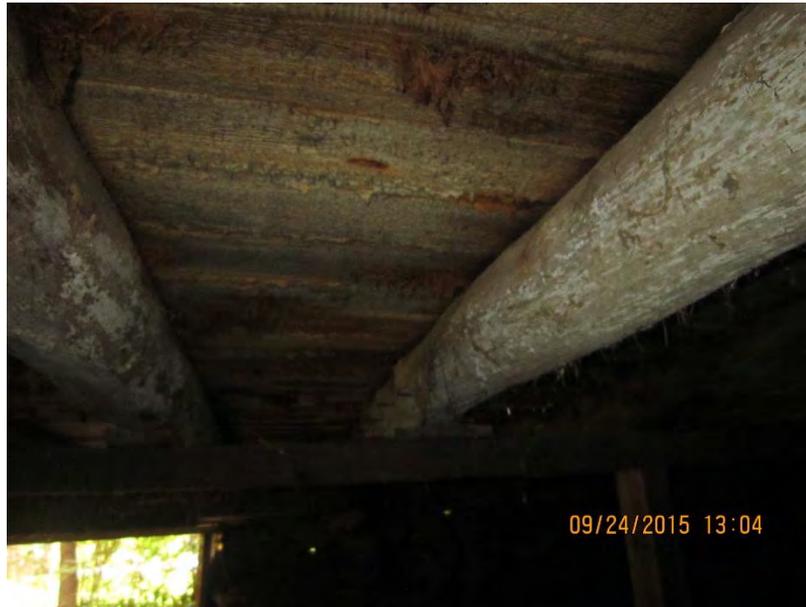
Subfloor signs of mildew and rot

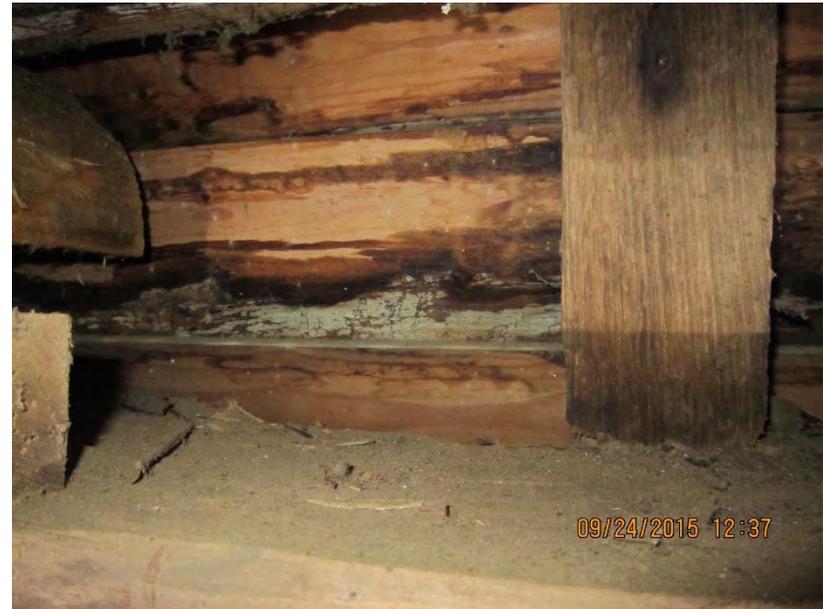
Evidence of water damage
