PROJECT NAME
Parks Building Evaluation

PROJECT NO.
10635-00

September 23, 2015

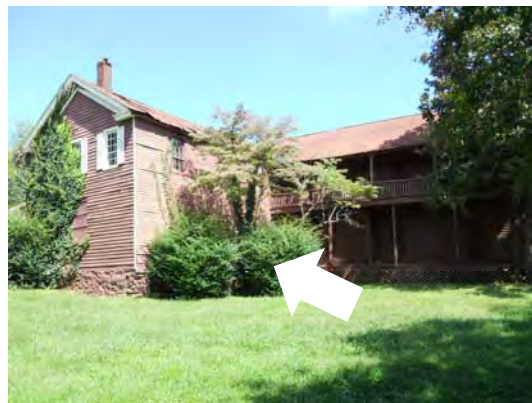
Figure 5 Rear elevation of porches. Arrow points to the elevation with vinyl siding.

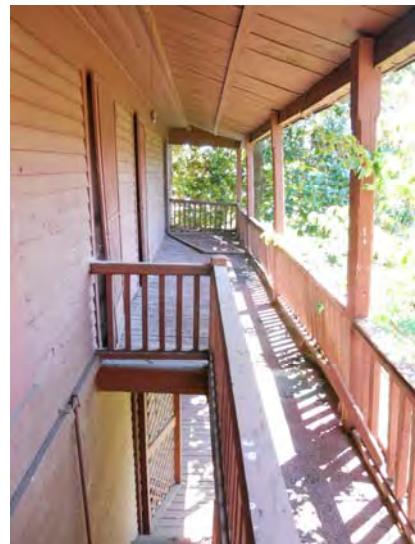
Figure 9 Rear porch - Not accessible

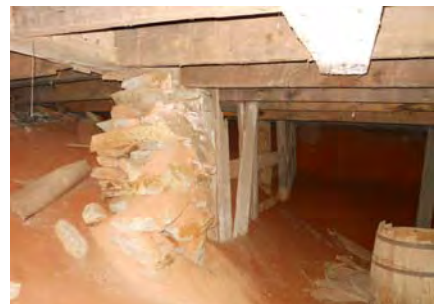
- a. Foundation – The entire foundation is comprised of stack stone and has mortar in the joints in exterior locations. Some of the areas do not have any mortar. There is at least one later brick pier that was added to the basement foundation system.
- b. Beams – The floor beams are a combination of logs and roughhewn logs that are 10-12” deep. A supplemental line of posts and beams were added over time to the framing of the first floor. Many of the posts are not secured to the dirt floor, several beams are rotting and decomposing due to moisture infiltration.
- c. Framing – The framing of the walls is not openly discernable, but the roof is of heart pine aged lumber and thin sliced logs. Original framing is in place.

Figure 19 Stack stone foundation

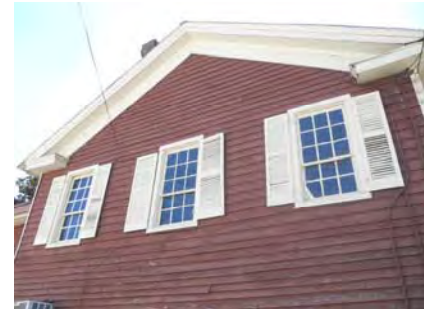
Figure 23 Windows and shutters on the northeast elevation

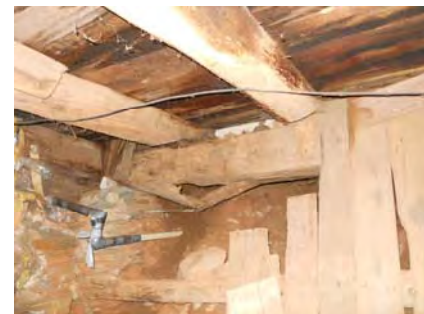
Figure 24 The failing beam under the main floor

1. Structural Beam - The primary structural beam under the front portion of floor is failing. It has significant termite damage and is collapsing. It should be evaluated by a structural engineer and shored to prevent total failure. The floor above this area is damp and care should be taken to not let this condition deteriorate further. There is termite and post beetle damage in a number of the floor joists at this level, as well.
2. Moisture in the crawl space - There is visible water infiltration in the basement area that appears to be coming through the southwestern end of the building. It appears to be coming through the southwest corner of the building.

1. Remove vegetation from the building and secure the exterior envelope. The vegetation will continue to damage the building if left unchecked.
2. Determine if reasonable measures can be taken to save the structural beam under the first floor from collapsing. Engage a preservation architect and structural engineer to recommend immediate shoring for the floor for the safety of everyone entering the building. Make sure all other areas of possible concern are shored (i.e. sloping floors, second floor porch, chimneys).
3. Secure the building so that vagrants and animals do not enter the structure. Clean out the dirt, debris and hazardous guano. Document and archive all existing finishes and newspapers.

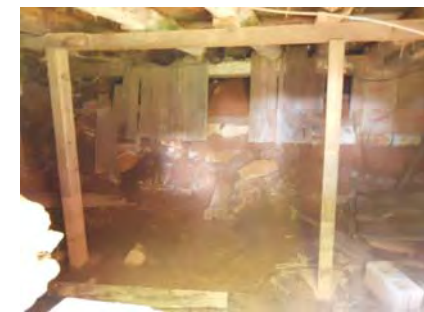
Figure 25 Moisture in the basement

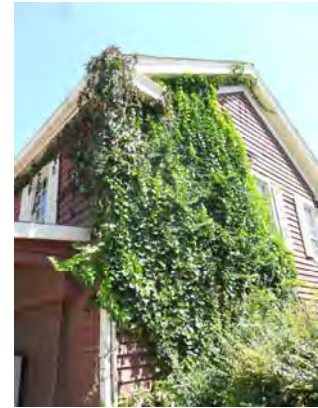
3. Vegetation - Overgrowth of trees, weeds and vines on the building are compromising the entire southwest end of the structure. They are rooted in the side of the building and should be removed in order to maintain the structure. There is a large magnolia near the back of the structure that is imposing on the building, as well.
4. Pronounced sloping of the floors - It is to be expected that a structure of this age will have sloping floors. All of the floors slope somewhat, however the floor of the porch above the front of the building and the second floor of the rear porch are sloping at an angle that is not within an acceptable tolerance for normal use. The second floor porch at the rear of the building also has extensive rot and damage to the ends of the boards. It was not walkable on the day of inspection due to boards that appear to be rotten and failing.

Figure 26 Vines growing on the building should be removed and the building protected from further damage

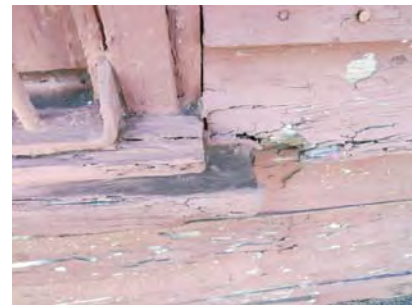
5. Perimeter sill beams - The visible ends of some of the perimeter sill beams are soft and exhibit some rot where exposed. Each sill beam was not visible from the underside of the structure, but some rot was seen from the exterior.
6. Limited areas of rot around windows and window sills - Where the window sills have been left unpainted over time, there is rot and damage at the intersection of joints and elements.

Figure 27 Rotten wood at the joint between the sill and the siding
