CONDITION ASSESSMENT REPORT WITH PICTURES

40 East Main

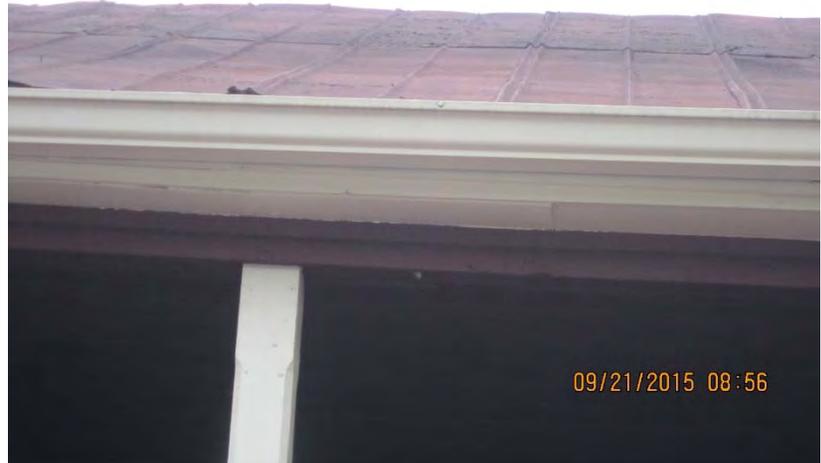
Section 1 Roof

Deterioration rusted metal

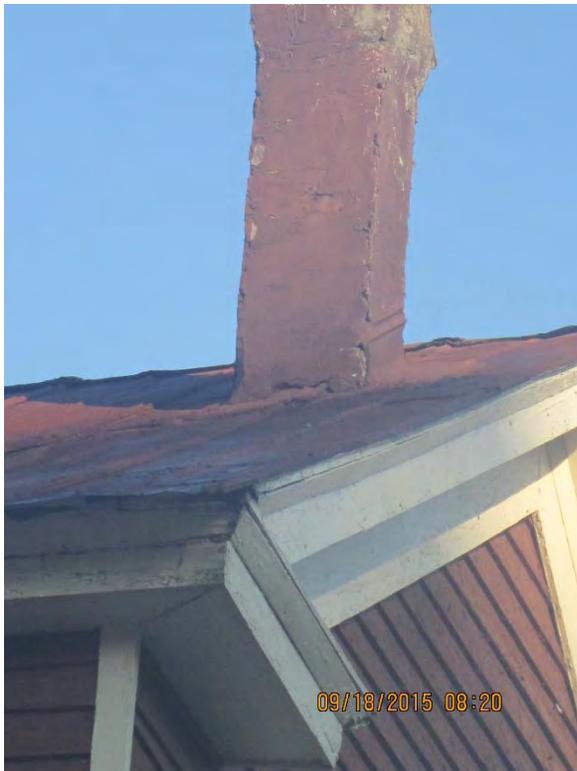
Section 1 Roof

Deteriorated flashing

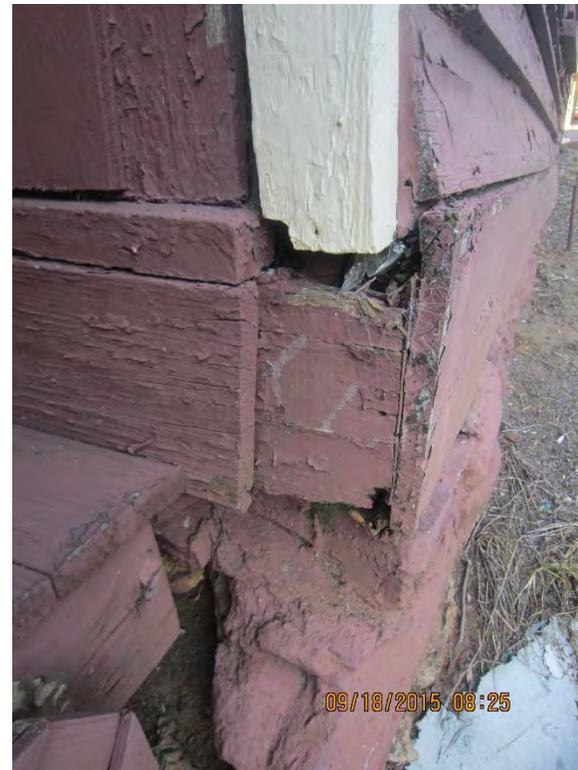
Section 3 Exterior Walls

Deteriorated corner support

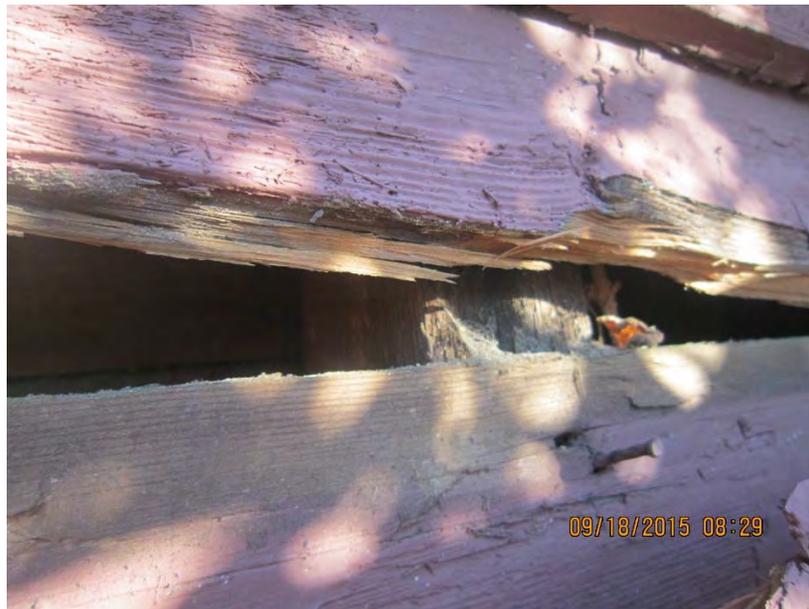
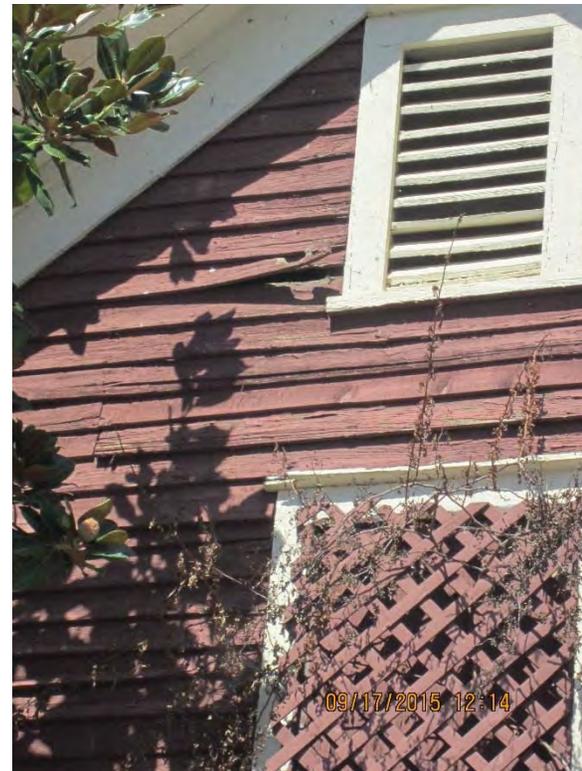
Dry rotted siding

Exterior wall leaning

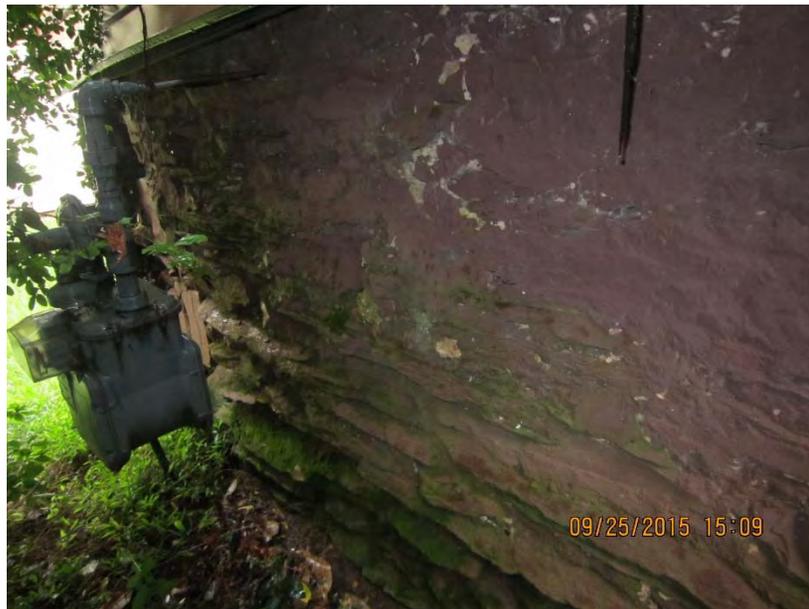
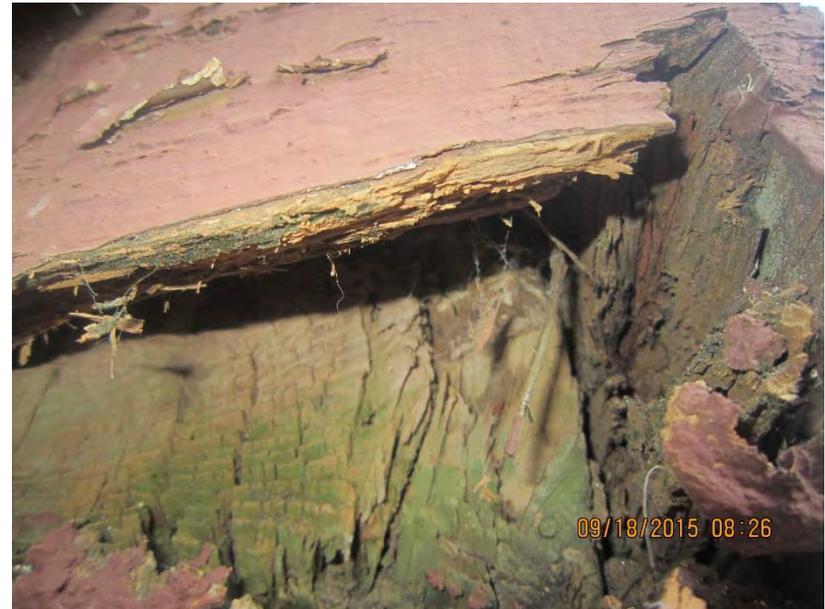
Evidence of mold/mildew

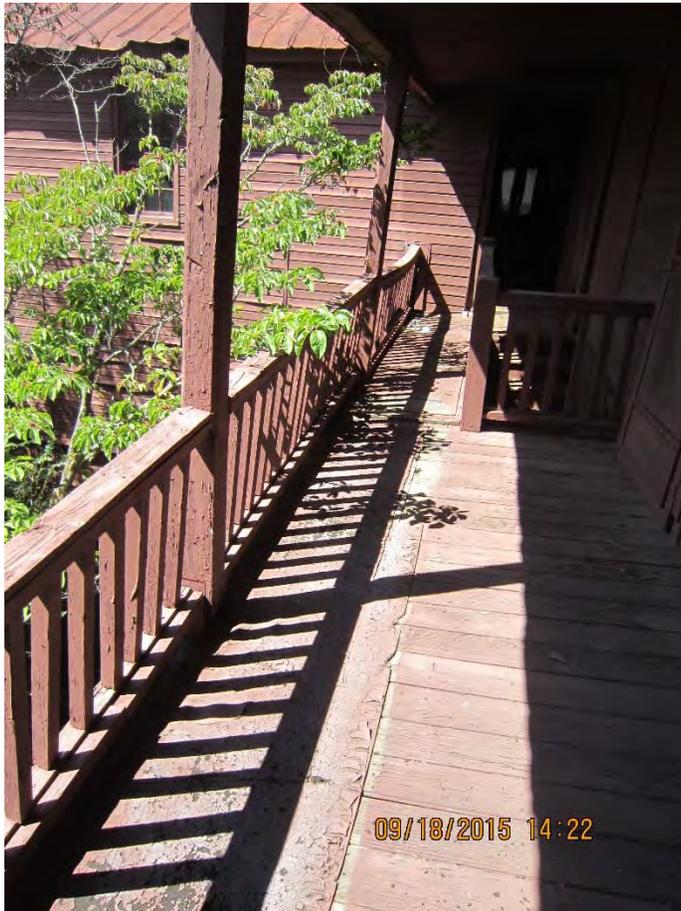
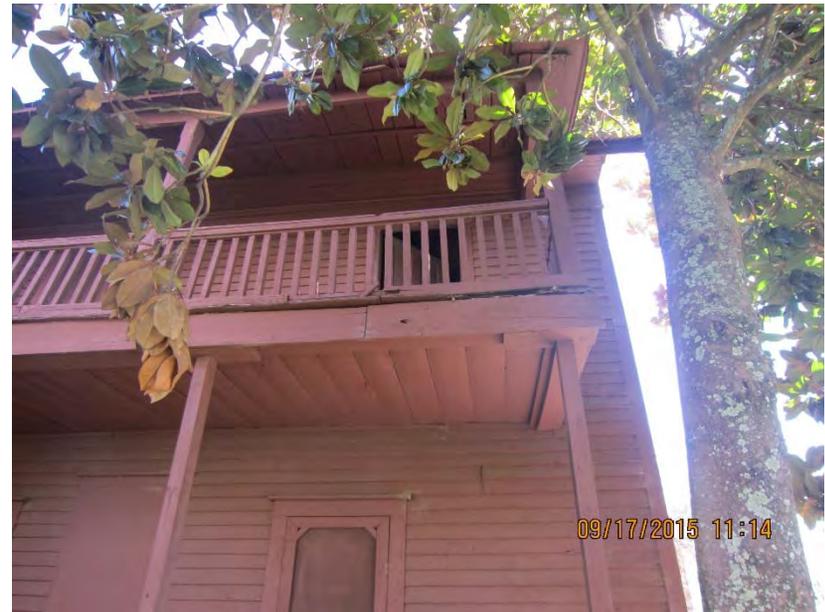
Upper Rear Porch dangerous slope

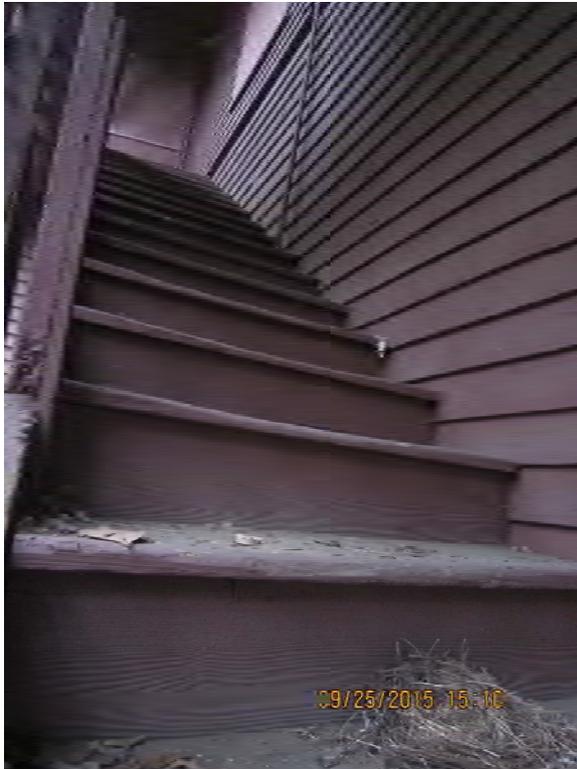
Stairways are deteriorated and need to be replaced.

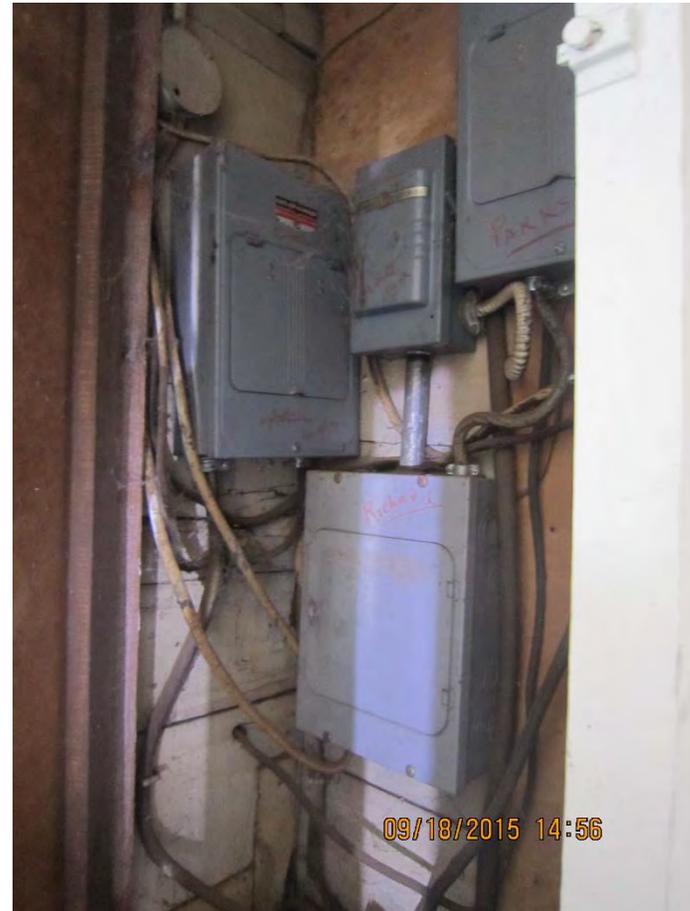
Electrical panel- frayed wires

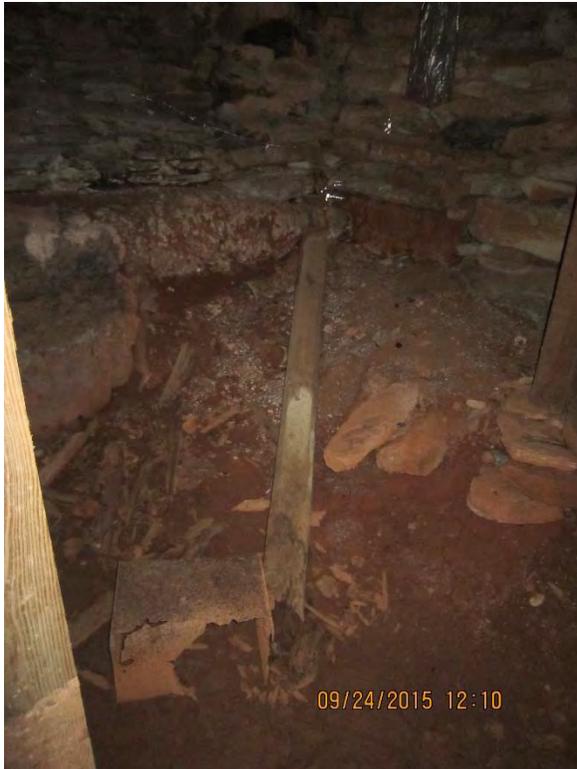
Drainage problems under structure – high moisture level in very dry weather period- mildew, mold and fungus present with dank, musty smell; standing water may be present at times based on water marks/stains. No vapor barrier is present. Loose pieces of wood including an old empty barrel lie in contact with the bare dirt inviting insects.

Water and moisture accumulation

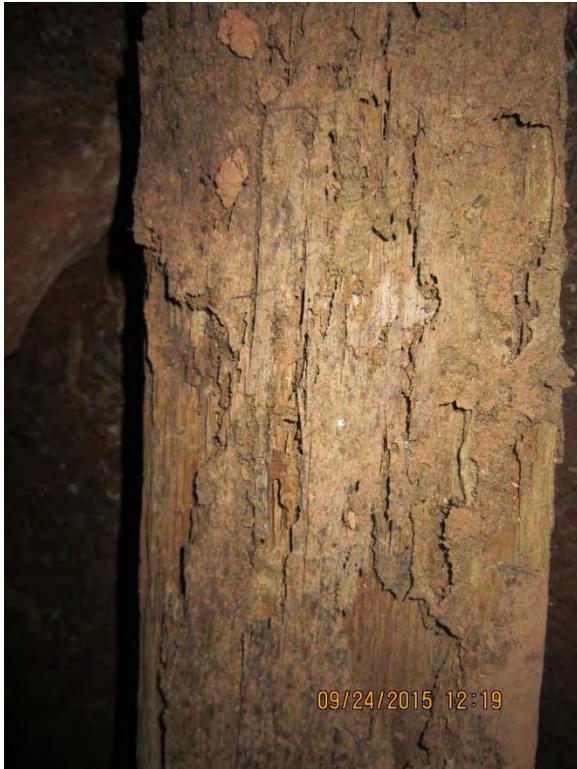
Signs of Termite Damage

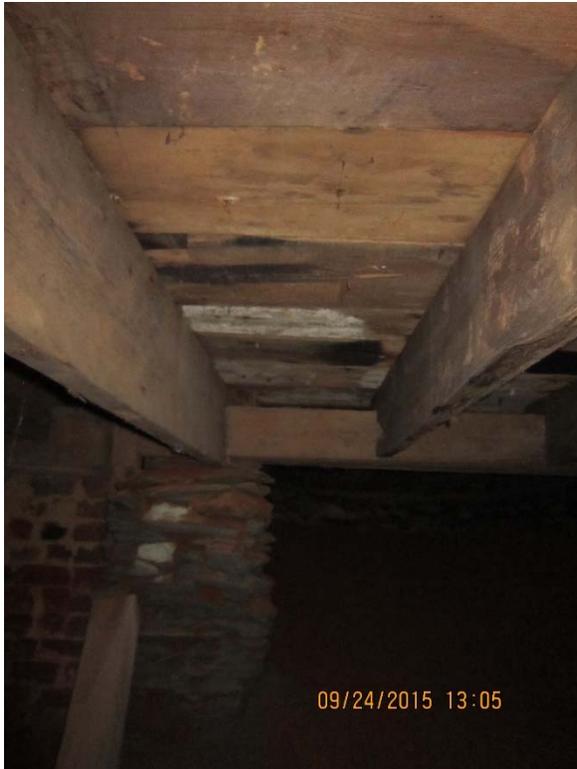
The lower floor decking above the subfloor shows rot, water damage and moisture.

Lower Floor Decking water damage

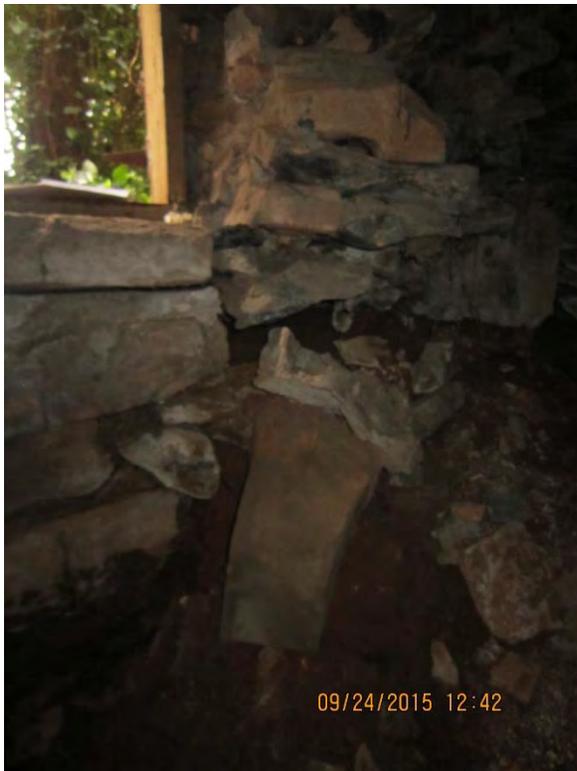
Vertical cracks, spalling, crumbling and deterioration in the stone masonry foundation with some missing stone. Temporary shored bracing appears inadequate to support dead or live load for occupancy.

Crumbling stacked stone foundation

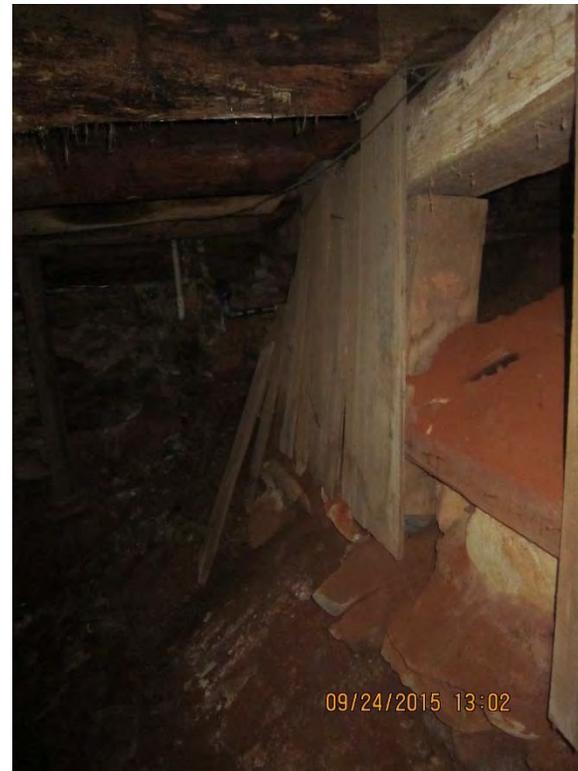
Falling stacked stone foundation
